CHAPTER 4: WATER QUALITY

B. Infrastructure Assessment Related to Water Quality

C. BMP Evaluation

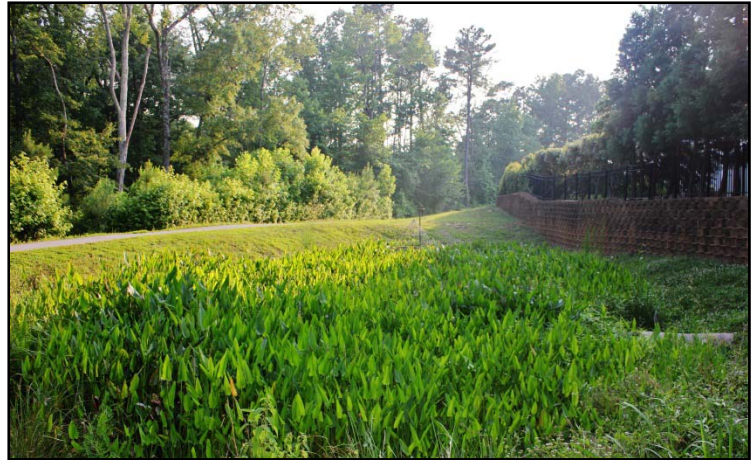
Stormwater Wetland at Bishop's Gate Community

The Bishop's Gate stormwater wetland is a good example of utilizing the natural look of a stormwater wetland to blend in with the surrounding landscape. A greenway trail meanders by this stormwater wetland making it a focal point to pedestrians and increasing interaction with the BMP. Additionally, a wall and hedgerow have been utilized as a screening mechanism for the adjacent residential community.

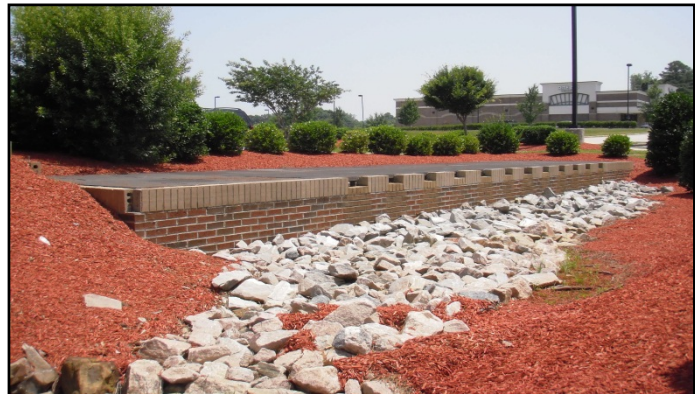
Sand Filter at Kangaroo Gas Station, Harrison Pointe Shopping Center

This underground sand filter at the Kangaroo Gas Station is incorporated into the surrounding landscape. The vegetation provides a visual buffer from the parking lot, and the brick facing matches the surrounding buildings. Additionally, the sand filter is set at grade allowing access for maintenance; however, the closed top serves as a safety feature to the public.

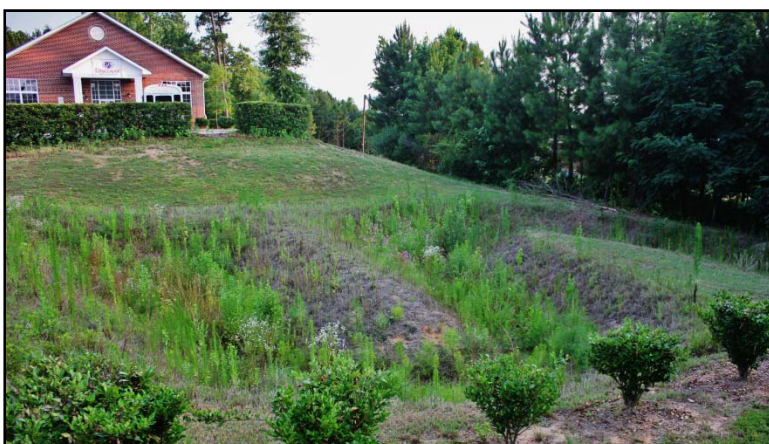
Grass Swale at Bright Beginnings Child Development Center

The grass swale at the Bright Beginnings Child Development Center provides secondary stormwater treatment while its meandering pattern provides an interesting site feature for patrons of the school.

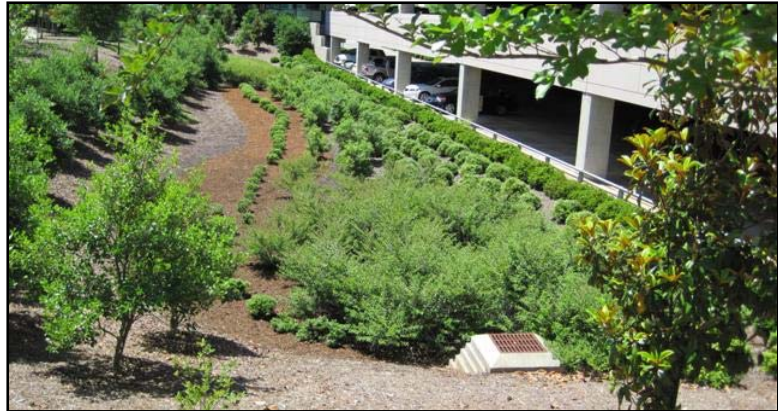
Bioretention Area at Cary Town Hall - South

This bioretention area utilizes a site location normally reserved for only landscaping and replaces it with a multi-function use, landscaping and stormwater treatment. Additionally, the BMP provides a visual buffer between the parking deck and the remainder of the Town Hall development.

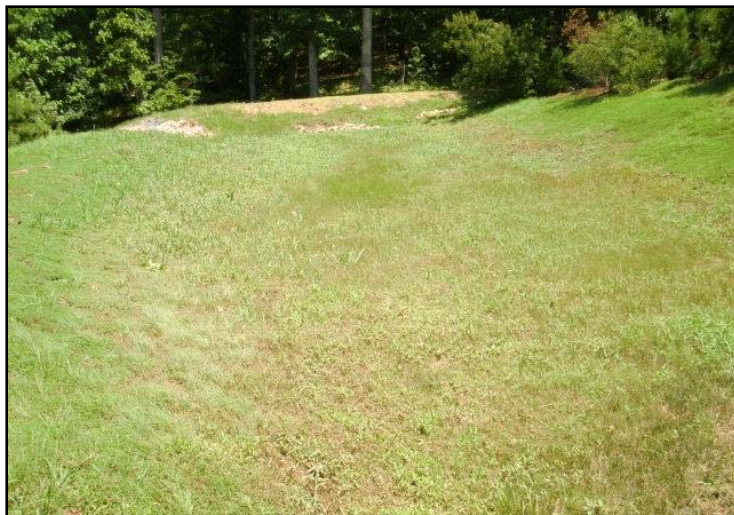
Dry Pond at Bishop's Gate Community

The Bishop's Gate dry pond provides an example of how this BMP can be blended into grassed landscape areas. With a good design and proper installation, dry ponds can provide little visual impediments to the public.

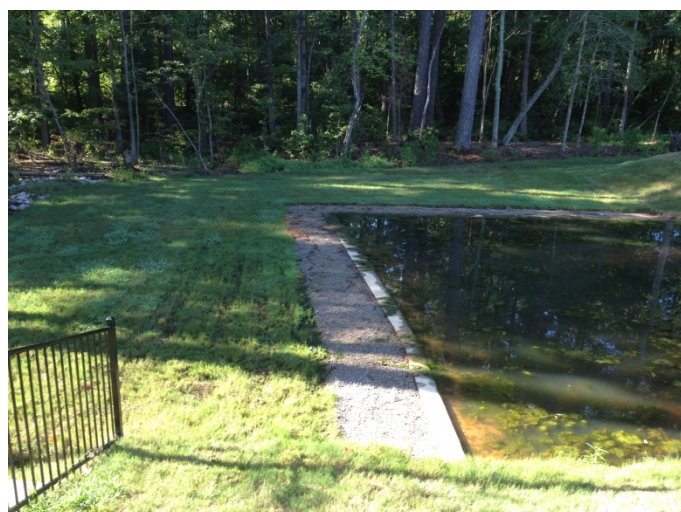
Level Spreader at Regency Park

This Level Spreader Regency Park is constructed of concrete with a curb gutter lip. It also has an engineered filter strip to promote infiltration which prevents pollutants from travelling to the downstream waters. Level spreaders are typically located near the buffer and away from public view; however, proper construction and maintenance are essential for these BMPs to be functional.

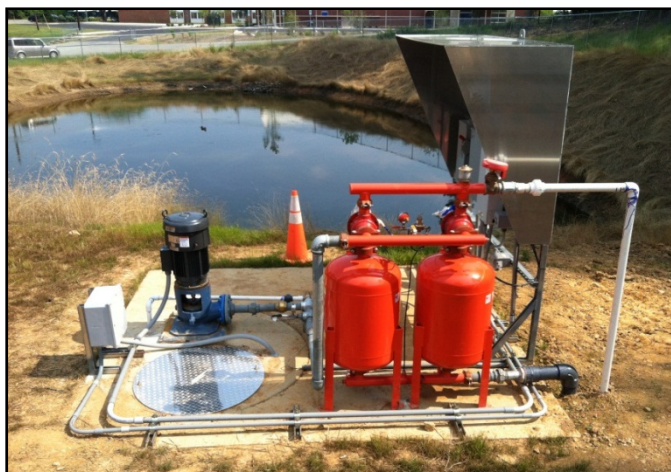
Charles W. Stanford Middle School, Hillsborough, NC

A Stormwater Irrigation Basin would modify the design of a Dry Detention Basin or Wet Detention Basin to include a volume of stormwater retention for rainwater harvesting. This retained stormwater can then be used as irrigation water onsite. Based on traditional treatment criteria, the retained stormwater volume would be in addition to the permanent pool volume required for water quality treatment when modifying a Wet Detention Basin. The permanent pool should not be

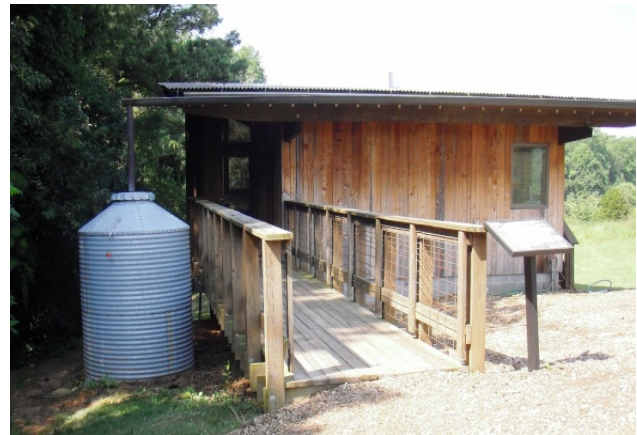
Prairie Ridge Ecostation, Raleigh, NC

Stormwater Cisterns consist of an above or below ground storage tank intended to retain stormwater for the purpose of rainwater harvesting. Harvested stormwater could be used for irrigation of site landscaping and/or incorporation into a building's toilet facilities. The new Jordan/Falls Lake Stormwater Nutrient Load Accounting Tool provides greater flexibility for the use of volume reductions to help meet pollutant loading requirements for Total Nitrogen and Phosphorus, and makes Stormwater Cisterns a more viable treatment option in the Jordan Lake Watershed.

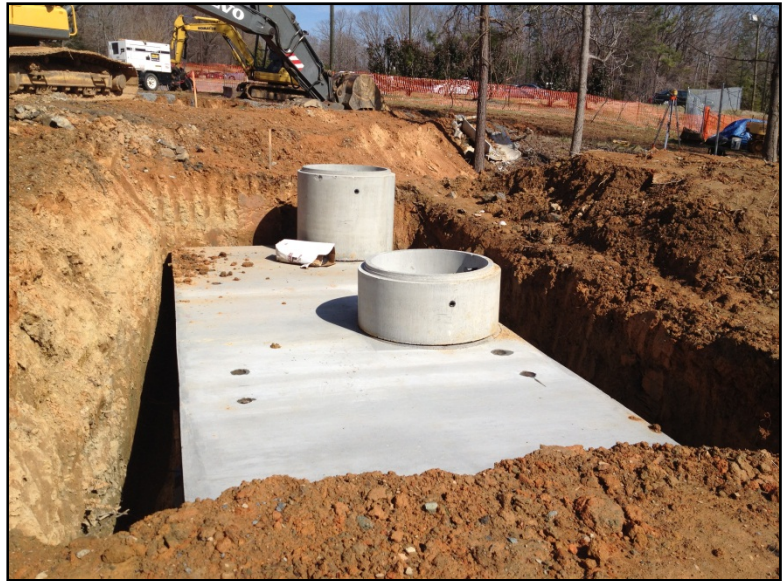
Charles W. Stanford Middle School, Hillsborough, NC

An increase in rainwater harvesting BMPs could create a greater need to provide oil and hydrocarbons pretreatment for stormwater flowing from parking lots and roofs. Water that is heavily polluted with oils and hydrocarbons can damage landscape vegetation and grass. Oil-water separators could be utilized as an inline pretreatment measure in rainwater harvesting BMPs to help reduce the amount of oil and hydrocarbons entering the BMP.

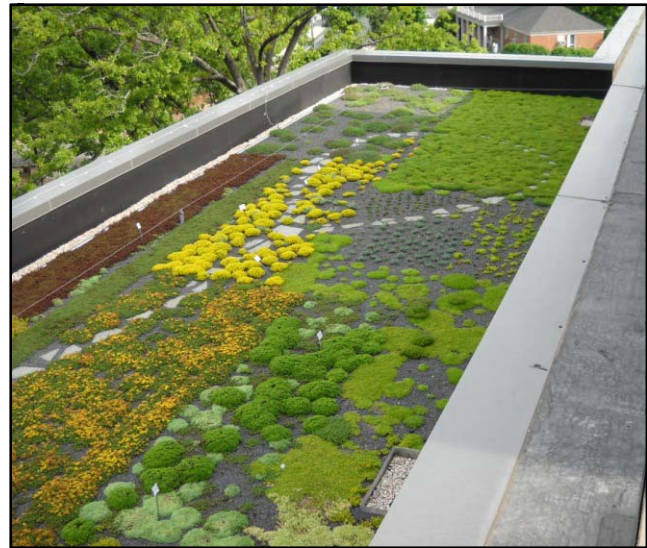
University of North Carolina Wilmington
Wilmington, NC

Stormwater Green Roofs are specifically designed to retain stormwater on the roof of a building to saturate soil media, irrigate the green roof vegetation, and sustain the process of evapotranspiration. Currently, the NCDWQ Stormwater BMP Manual (2007) does not credit Green Roofs with pollutant removal. Future research could eventually see modification for some pollutant removal; however, Green Roofs can be designed to provide substantial volume reduction in a traditionally unusable space. Green Roofs could be used in the Jordan Lake Watershed to retain stormwater and reduce the impervious area of the development, and essentially providing a net removal of the nitrogen and phosphorus loading from the site.

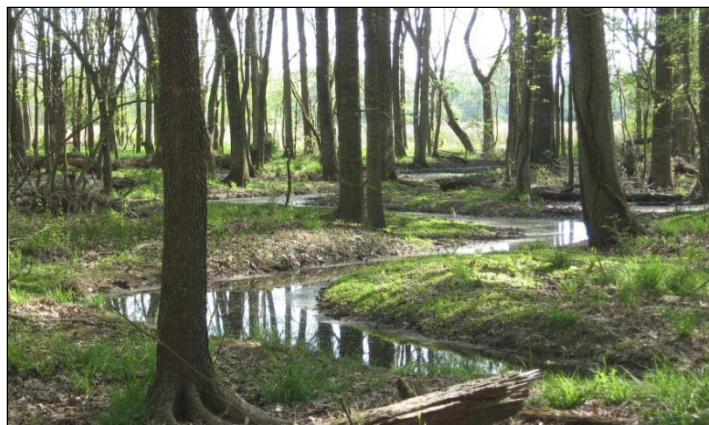
Beaverdam Mitigation Site, Harnett County, NC

Obtaining regulatory credit through implementation of traditional BMPs may not be feasible in every site scenario. Onsite Natural Area Restoration could include restoring function to degraded natural systems like streams, wetlands, and riparian buffers. These natural areas are often negatively impacted by site stormwater runoff resulting from development. Improving or restoring natural

function to these systems through new development can provide treatment of stormwater runoff for that site, and remediate degraded natural resources. Additionally, restoring natural areas could be used to generate mitigation credit (see Chapter 6-D). The Town would need to coordinate individual site credit through the North Carolina Division of Water Quality, or alternatively work toward a predetermined system for established regulatory credit for the restored function of these systems.

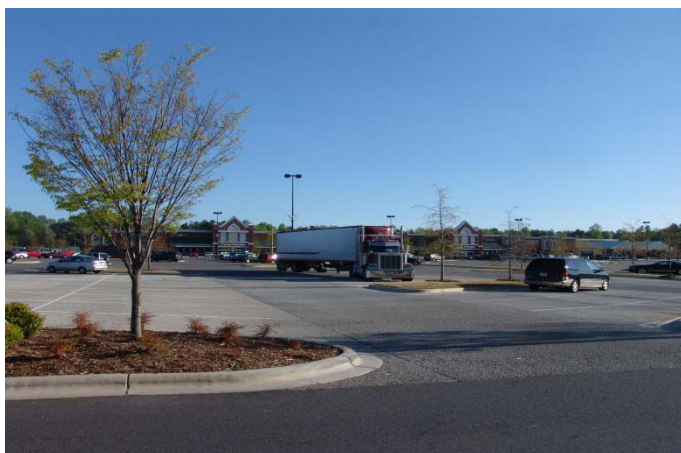
Wal-Mart Site, Indian Land, SC

The Division of Water Quality completed a major revision to the NCDWQ Stormwater BMP Design Manual that will provide regulatory credit for 70% or 85% TSS removal and a total nitrogen (10% or 30%) and phosphorous (10% or 60%) removal efficiency for Permeable Pavement meeting the modified design requirements. This revision provides developments greater flexibility and incentive to install permeable pavement onsite and in-lieu of traditional paved parking lots. It also includes design parameters based on water quality or detention only. Additionally, the Jordan/Falls Lake Stormwater Nutrient Load Accounting Tool provides nitrogen and phosphorus effluent concentrations for Permeable Pavement implementation. These revisions make Permeable Pavement a more viable stormwater quality and quantity solution that can be used in appropriate settings throughout the Town of Cary.

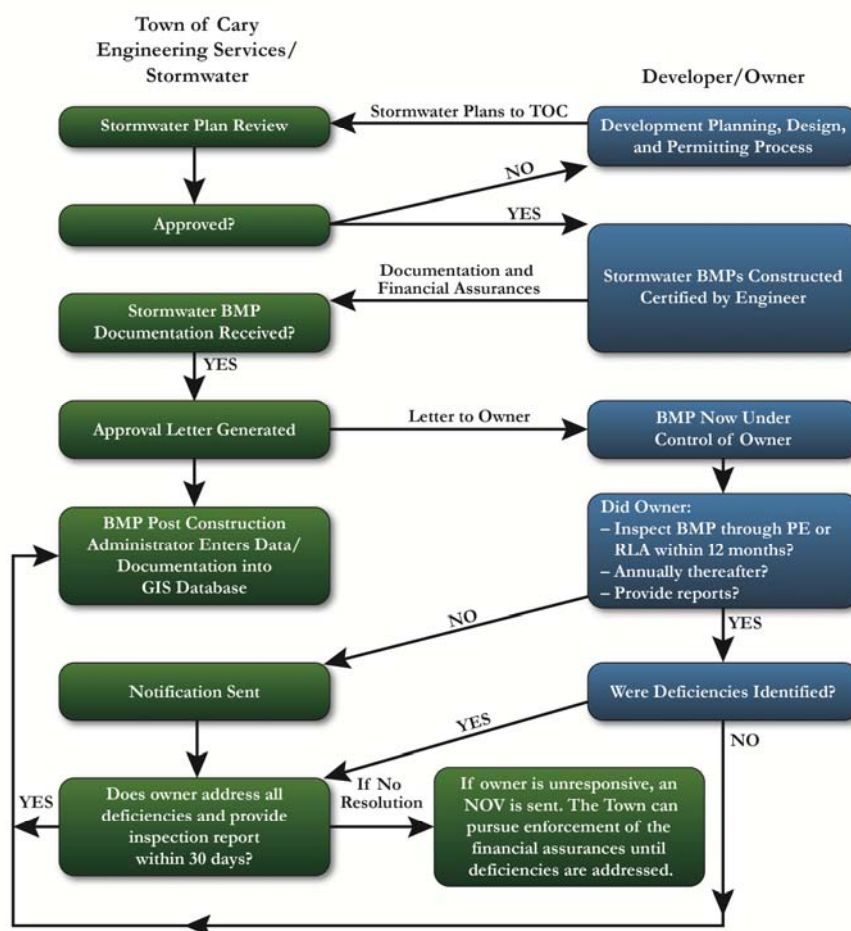
Figure 4-7 - Stormwater BMP Inspection Program Flow Chart

The inspection report is due on the one-year anniversary of the issuance of the Town’s BMP approval letter, and reports are due annually thereafter. The inspection forms are updated annually to ensure that the most relevant information is recorded. The owner is required to retain a private, independent inspection company to inspect the BMP and provide the report. Under this inspection system, there is incentive for these companies to accurately identify and address issues with the BMPs such as lack of grass cover, leaking or damaged structures, and unhealthy wetland and screening vegetation. Since the majority of existing BMPs are wet detention ponds, stormwater wetlands, or bioretention areas, there is a strong understanding of the function and maintenance of these systems among the various companies that provide inspection services. Refer to Section 4C for a detailed review of the types of BMPs commonly used in the Town.

If an inspection report identifies a deficiency, the owner has 30 days to address the deficiency. Since the inspection process requires that identified issues with a BMP be addressed through maintenance, repair, or replacement, the service life of the BMP is extended indefinitely. If the owner refuses to make required repairs, the Town has enforcement mechanisms and the required financial assurances to ensure the BMP is maintained. Owners are given a choice of the financial assurances they can provide: cash or an “ever-green” letter of credit. At this point, these mechanisms have not been needed, which speaks to the success of the Inspection Program in meeting its goal of maintained BMPs.
