## APPLICATION FOR HISTORIC LANDMARK DESIGNATION

Historic Name: Carpenter Supply Store + Farmer's Cooperative and Meeting Hall  
 Current Name: Carpenter Farm Supply Company Complex

# Carpenter Farm Supply Company Complex

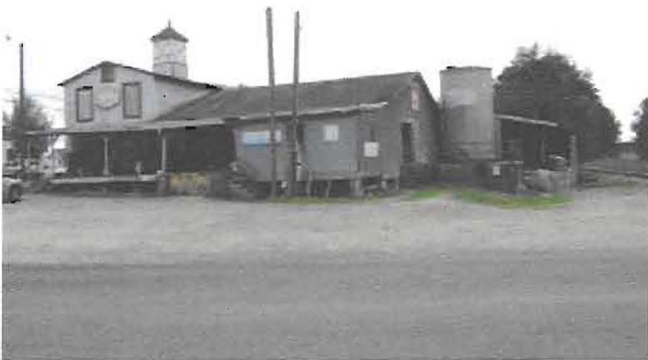
LM\_CarpenterFarmSupplyCompanyComplex\_co-op facade.jpg

The Farmers' Cooperative is a two-story, frame, gable-front building with corrugated metal siding. The facade faces north and features a centered, single-leaf paneled door at the first story and a pair of boarded windows at the second story. A square vent pierces the front gable end. The metal-covered roof has a slight overhang and narrow rafter tails are exposed. A squared cupola with pyramidal roof was added to the building in the 1990s. The east side of the Farmers' Cooperative has no fenestration and the corrugated metal siding extends to the ground, obscuring the foundation type and material. Additions obscure both the west side elevation and the lower story of the south-facing rear elevation. The upper portion of the rear elevation matches that of the facade, with a pair of boarded windows at the second story and a square vent at the rear gable end.

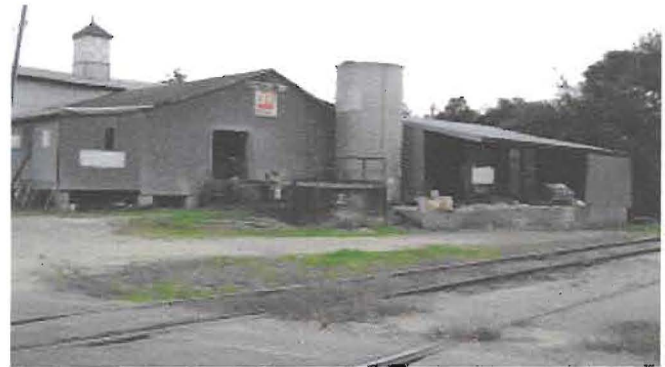
LM\_CarpenterFarmSupplyCompanyComplex\_co-op west elevation.jpg

Appended to the west side of the Farmers' Cooperative is a ca. 1950 single-story seed warehouse of timber-frame construction with corrugated metal siding. The side-gabled building has a ca. 1970 shed-roofed addition across its rear elevation and a ca. 1985 loading dock, silo, and open-sided storage shed at its west side. A ca. 1950 shed-roofed front porch spans the facades of the original Farmers' Cooperative and the later warehouse. The porch has sawn timber porch columns and a concrete-block pier foundation. In front of the Farmers' Cooperative, the porch floor is wood; it is concrete in front of the warehouse and extends slightly north beyond the edge of the porch roof, serving as a loading dock. The northwest corner of the porch was enclosed in the early 1970s to form an office.

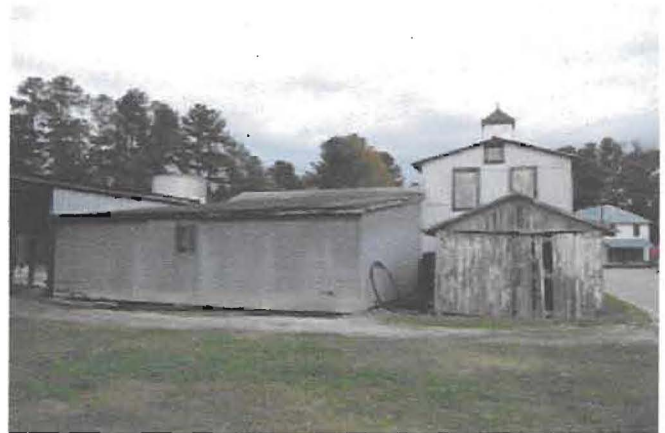
LM\_CarpenterFarmSupplyCompanyComplex\_co-op rear elevation.jpg

A single-story, frame, gable-end, ca. 1950 truck garage extends from the rear elevation of the ca. 1880 Farmers' Cooperative; weatherboard clads the sides of the garage and metal covers the roof, which has a slight overhang. The garage's south-facing elevation has a double-leaf hinged door of vertical boards with vertical wood siding sheathing the building's gable end.

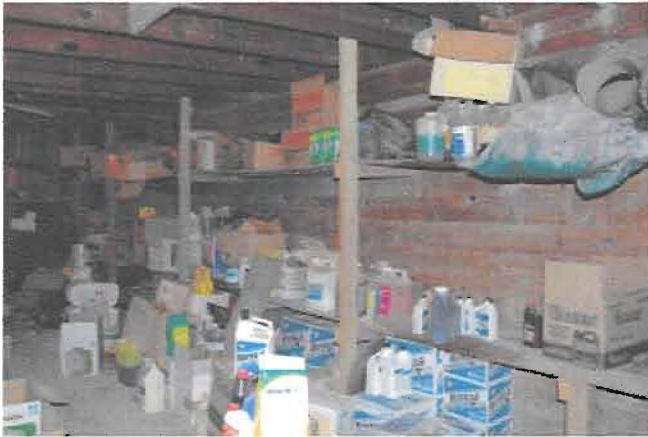
LM\_CarpenterFarmSupplyCompanyComplex\_co-op interior.JPG

The first-floor interior of the Farmers' Cooperative features wood walls lined with wood shelving on the east and west sides. Wood rafters support the second-story floor; much of the interior of the ground floor and the entire second story meeting-hall space was inaccessible during survey due to the building's current use as fertilizer storage for the retail business.

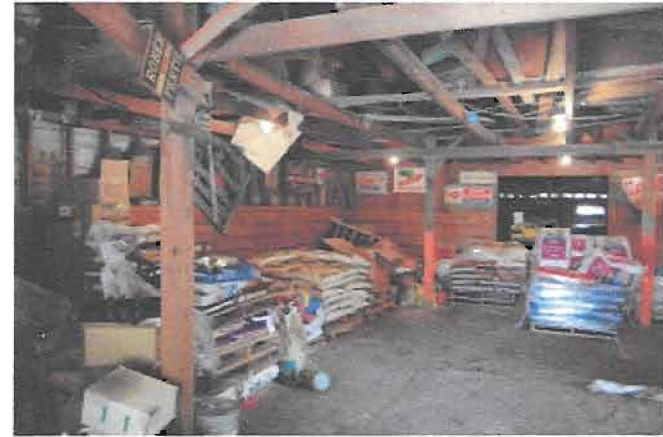
LM\_CarpenterFarmSupplyCompanyComplex\_co-op addition interior.jpg

The warehouse interior is open and features wood-clad walls and a concrete floor. The north and west sides of the main warehouse space have large door openings that lead to the loading

docks; the openings can be secured with sliding wood doors. A third, open doorway in the south wall leads to the shed-roofed rear warehouse addition, which is also an open plan and is only accessible through the main warehouse space. A single window centered on the rear elevation lights the space.

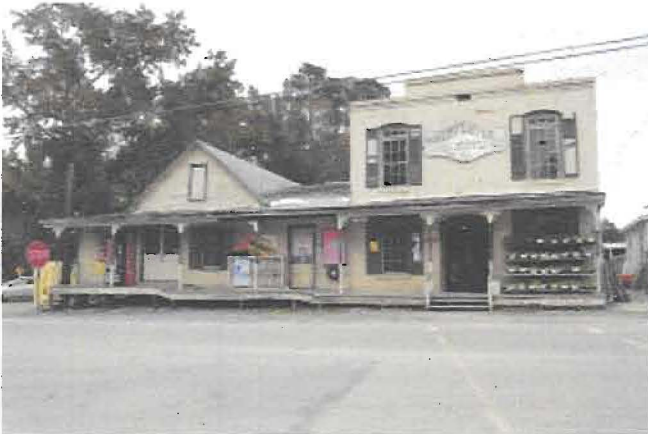
LM\_CarpenterFarmSupplyCompanyComplex\_store facade.jpg

The building's west-facing front elevation includes the facades of the 1885 and 1916 store buildings joined by the 1917 addition. A shed-roofed porch with turned wood porch columns adorned with sawn brackets stretches across the width of the building's facade. The frame sections of the building include both weatherboard and German siding at the facade. Double-leaf, partially glazed, paneled doors provide access to the interior of the 1885 store building and a six-over-six double-hung wood window to the right of the door lights the interior. A rectangular opening in the gable wall has a wood-plank door on metal hinges. The 1917 addition features only a single-leaf replacement door in its narrow facade. The brick store building has a symmetrical facade consisting of centered, double-leaf, partially glazed, paneled doors in a segmentally arched doorway flanked by six-over-six double-hung sash with three-light transoms in segmentally arched openings. Each of the two identical windows that light the interior of the second story are aligned directly above their first-floor counterparts. A low, stepped parapet with simple projecting brick cornice tops the facade wall of the brick store building. All windows across the entire facade are flanked by louvered wood shutters.

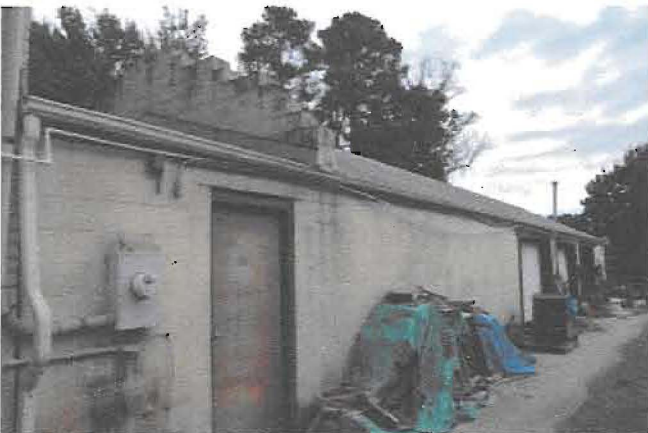
LM\_CarpenterFarmSupplyCompanyComplex\_store's rear garage addition south elevation.JPG

A gable-roofed concrete-block garage addition extends to the east from the back of the south end of the shed-roofed concrete-block store addition. A firewall with stepped parapet separates the two sections. The rearmost portion of the garage addition contains three garage-bay openings at the south elevation, but the gable-roofed addition otherwise lacks fenestration. Weatherboard clads the gable end at the east end of the building.

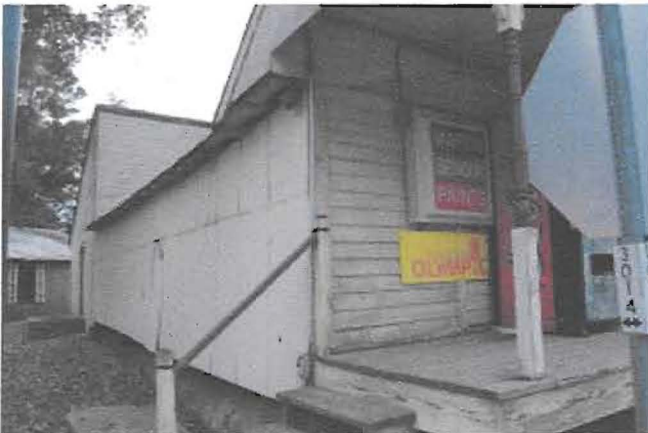
LM\_CarpenterFarmSupplyCompanyComplex\_store north elevation.jpg

An original shed-roofed room lines the north elevation of the 1885 store building; the exterior completely lacks fenestration and features weatherboard at the facade and corrugated metal siding along the north elevation. A single-story, concrete-block addition at the back of the store buildings spans the width of the building and features a steeply pitched shed roof. A metal double-leaf door provides access to the concrete-block addition from its north elevation and a single-leaf metal door pierces its south end, but the entire east side of the concrete-block rear store addition lacks fenestration.

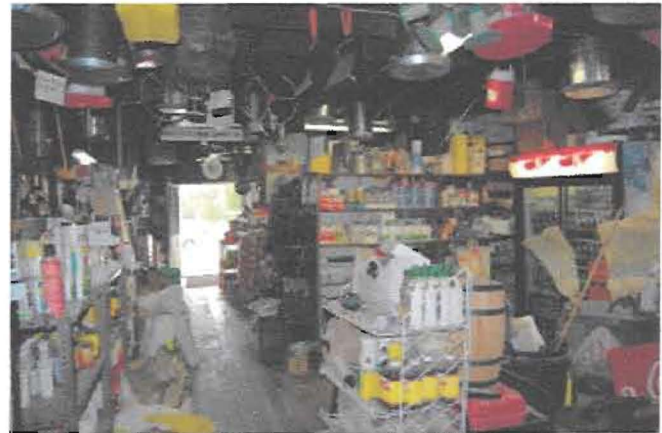
LM\_CarpenterFarmSupplyCompanyComplex\_store interior.jpg

Today, the entrance to the store is through the double doors in the brick store building. The interior of the brick store features a wood floor with brick and plaster walls lined with wood shelving and crammed with merchandise. The original back doorway remains and leads into the concrete-block rear addition; the doorway is flanked by six-over-six sash windows with three-light transoms as seen at the front of the building.

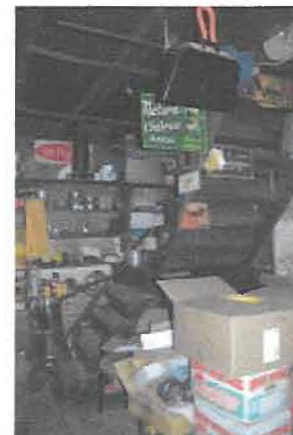
LM\_CarpenterFarmSupplyCompanyComplex\_store interior showing stair to second floor.jpg

A wood stair at the northeast corner of the space leads to the second story, which features an open room occupying roughly the rear two-thirds of the second floor. At the front of the building, two smaller rooms served as an office for William Carpenter and a barbershop. No furniture or finishes indicating these uses survive.
