CARY HISTORIC LANDMARK DESIGNATION APPLICATION

Historic Name: _____ John L. and Henrie G. Sears House _____

Street Address: _____ 5104 Sears Farm Road, Cary, NC 27519 _____

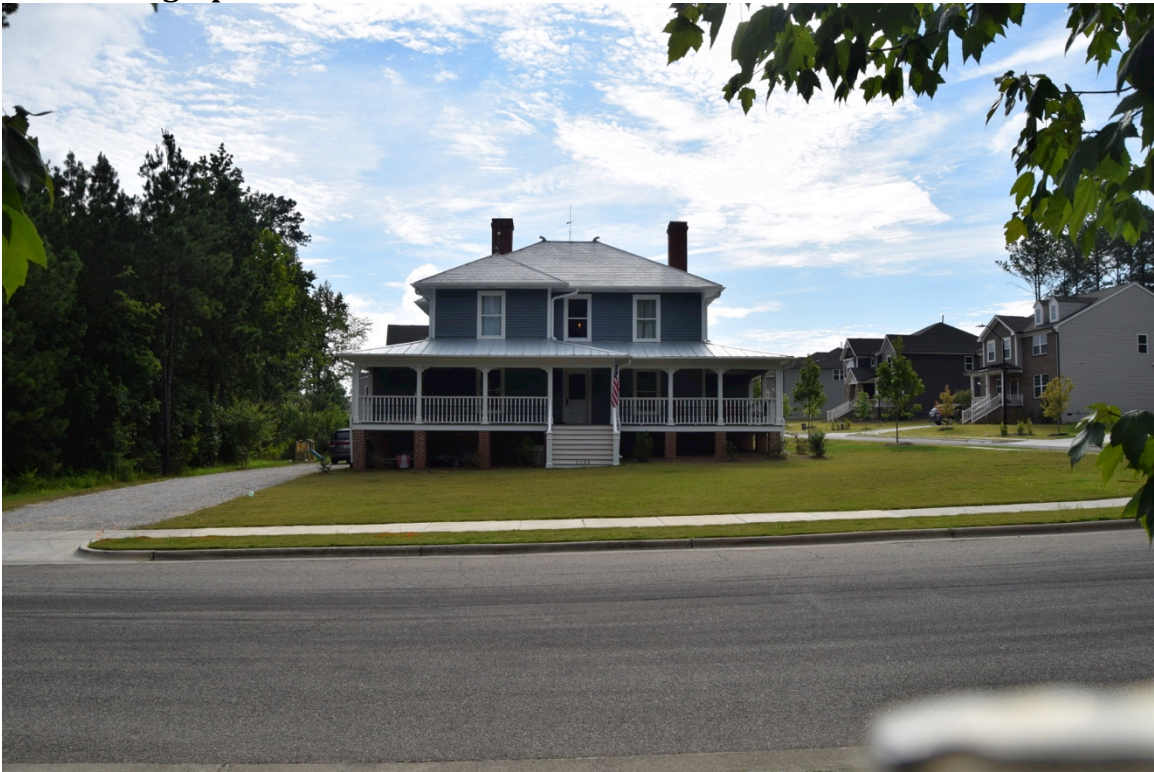
John L. and Henrie G. Sears House, overall site, view E

In its new location, the house faces west, overlooking Sears Farm Road from a parcel that slopes down toward the street. A new continuous brick foundation supports the house but the porch is set on brick piers. The change in grade makes the foundation higher at the front than at the back, and the house stands much taller here than at its flatter original location. The land surrounding the dwelling has been developed into a subdivision, although the dwelling's siting at northeast corner of Sears Farm Road and Cozy Oak Avenue give it a little more space. Additionally, a wooded stream buffer lies to the north. The dwelling's back is to the subdivision and a park is directly across the street. At the original location, on the same land but facing Green Hope School Road, there was a small, early twentieth-century farmstead and a large farm pond behind the house.

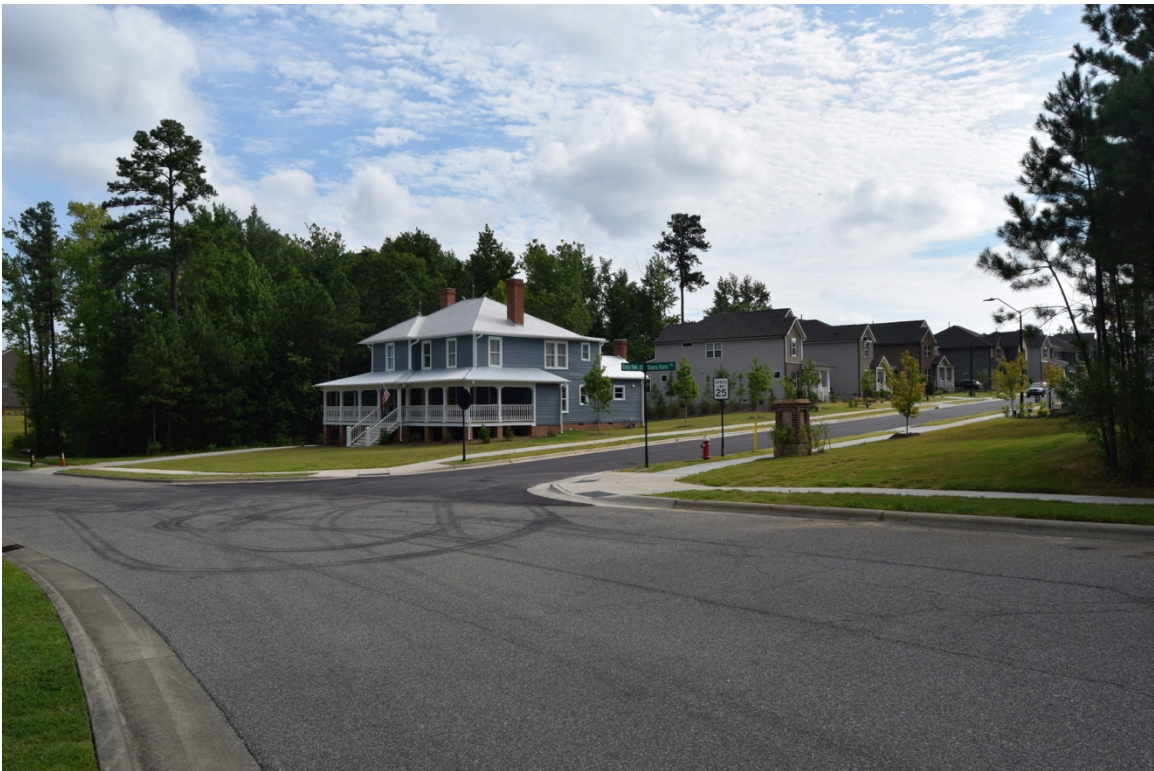
John L. and Henrie G. Sears House, overall site, view NE

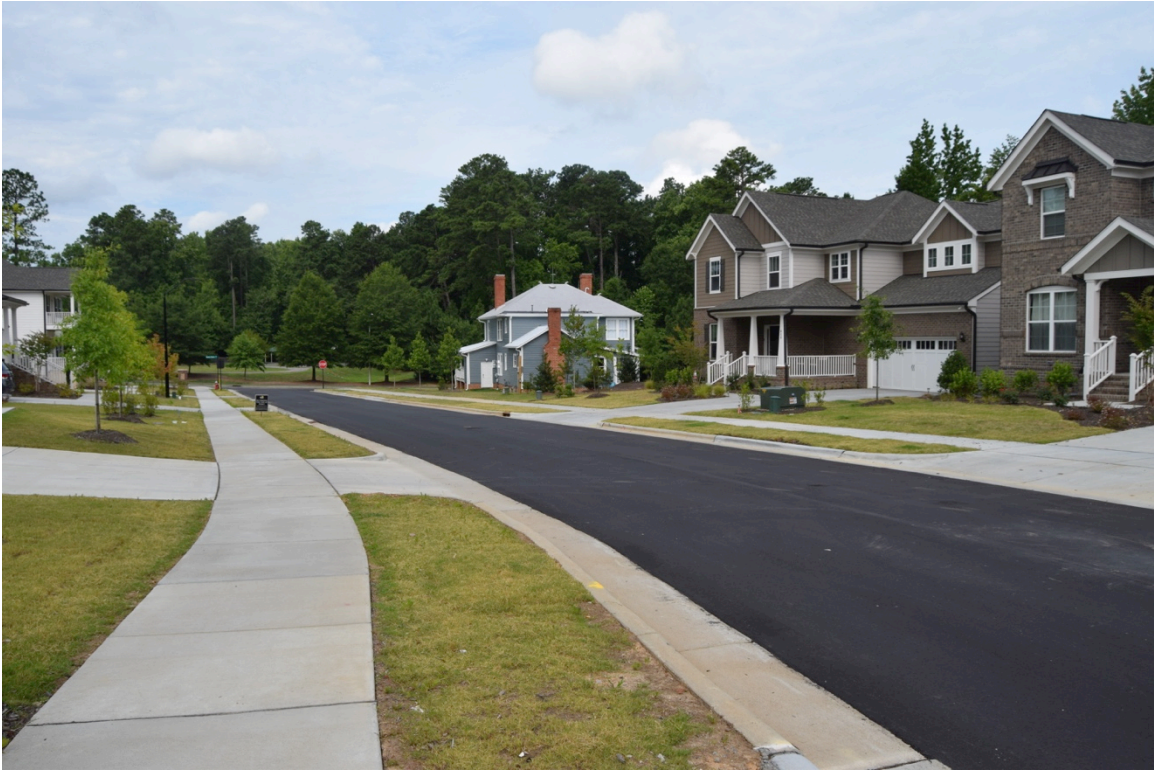
John L. and Henrie G. Sears House, overall site, view W

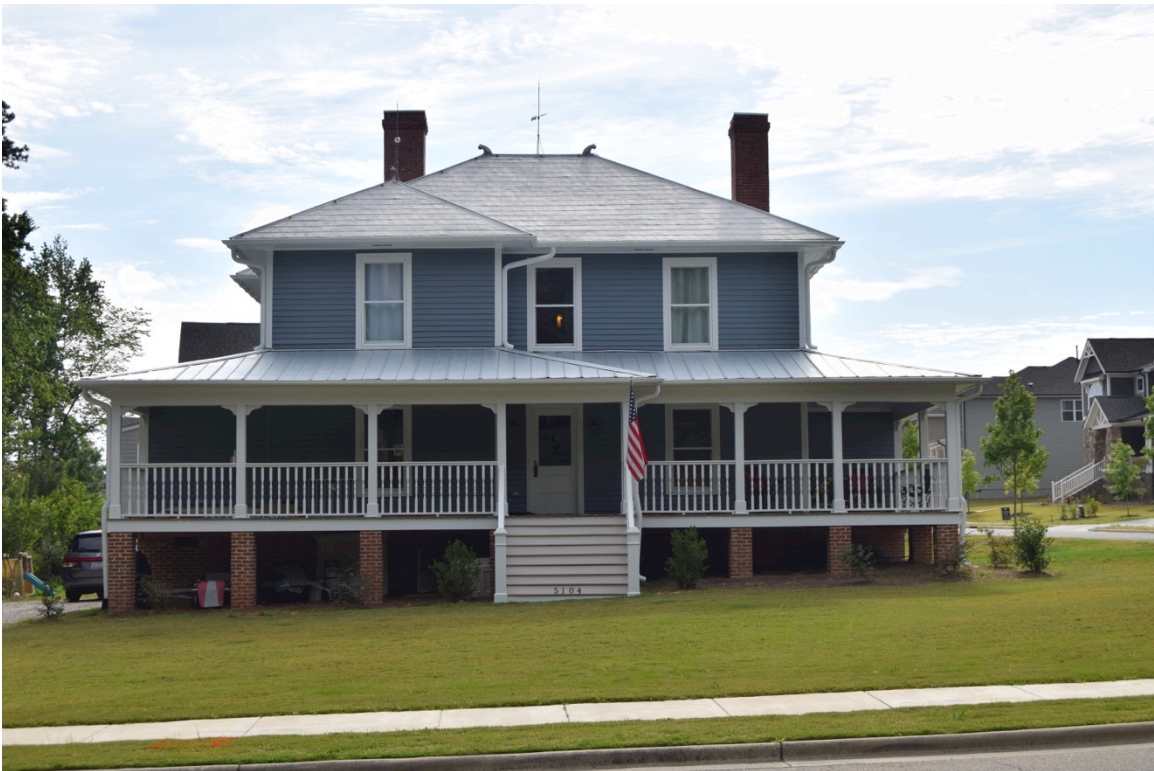
John L. and Henrie G. Sears House, façade, view E

The Sears House is ca. 1915 frame transitional foursquare with restrained architectural treatment that combines Queen Anne and Craftsman elements. It has a hipped roof, interior brick chimneys, wraparound front porch, and rear additions. The main block is double-pile and three bays at the facade. The north bay and north end of the porch project forward slightly. The back half of the north elevation also juts forward; together, these rooms slightly modify the dwelling's roughly square plan. The projections also break up roof slopes and wall expanses, keeping the foursquare from looking too boxy and alluding to the Queen Anne style previously popular in the area. Other architectural treatments include slightly overhanging boxed eaves and corner boards with quarter-round molding. Windows are one-over-one and occur singly and in pairs. The roofing material is pressed-metal panels with a shingle pattern and metal finials accent the roof's hipped corners. New standing-seam metal roof coverings replaced the pressed-metal roofing at the hipped-roof front porch, the shed-roofed back porch, and the gabled rear. The flat roof at the two-story addition is a new thermoplastic cover. The front porch features a turned balustrade and bracketed square posts with chamfered corners. The porch floor is wood decking and the ceiling is sheets of plywood finished to look like beaded tongue-and-groove boards. Trimwork covers most of the seams between sheets of plywood. A new wood stair with a prefabricated turned balustrade rises at the center of the porch, leading directly to the front entry's single-leaf, partially glazed paneled door.

The wraparound ends of the porch have been enclosed, but the entire expanse across the façade remains open. The enclosed north end is accessible only at the interior, from the parlor. A portion of the original corner board remains at the exterior to mark the original configuration. New one-over-one windows have been installed at the north side of the enclosure, replacing six-over-six windows that had appeared to date to the mid-to-late twentieth century. The porch enclosure at the south end is a windowless storage room accessed through a new exterior paneled door its east side.

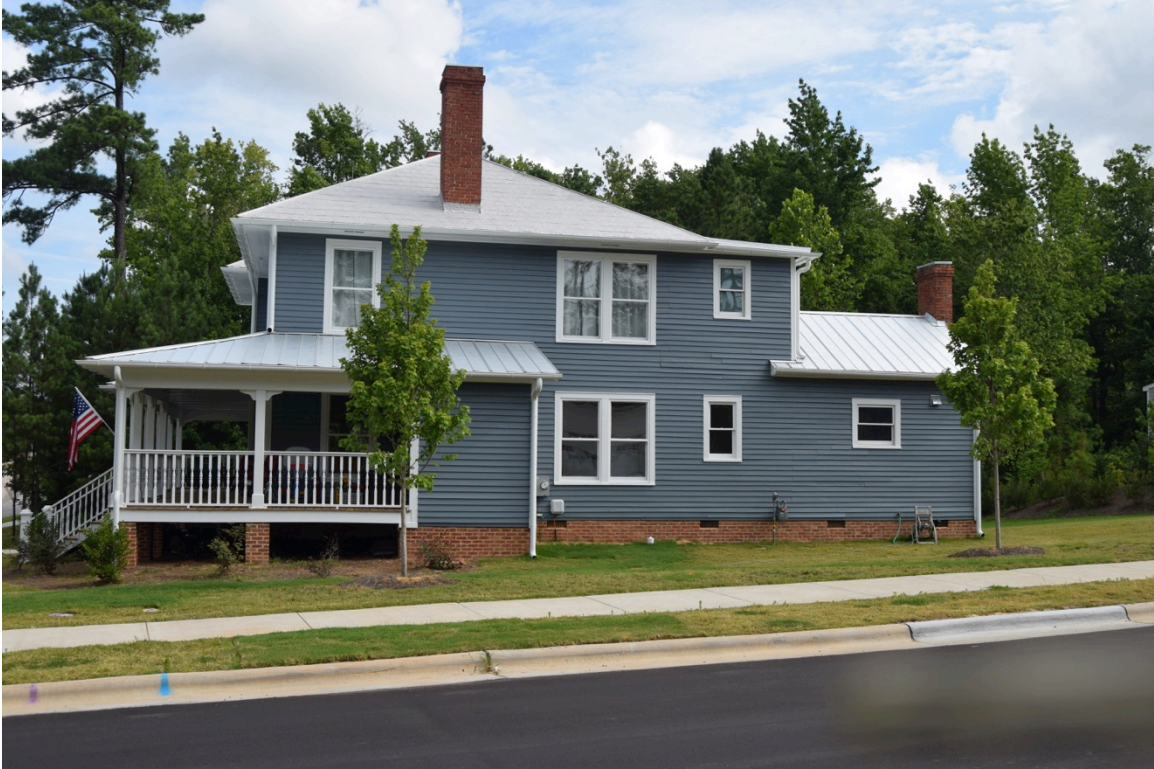
John L. and Henrie G. Sears House, S elevation, view N

Two sections at the back of the house are modified original additions. The first is a single-pile, two-story, flat-roofed block across two-thirds of the rear elevation. The

south side is flush with the south elevation of the house; no vestigial corner boards mark the back corner of the dwelling's main hipped block. A single-story gabled addition is appended to the back of this two-story section, also continuous with the south wall and lacking corner board seams. The gabled addition has an exterior end chimney of brick and a partially enclosed shed-roofed porch with wood decking and beaded plywood ceiling across its north side. The porch has a balustrade with square pickets and plain square posts; the owners plan to convert it from an open to a screened porch. New one-over-one wood windows have also been installed at the previously heavily renovated gabled addition, also replacing mid-to-late twentieth-century six-over-six windows.

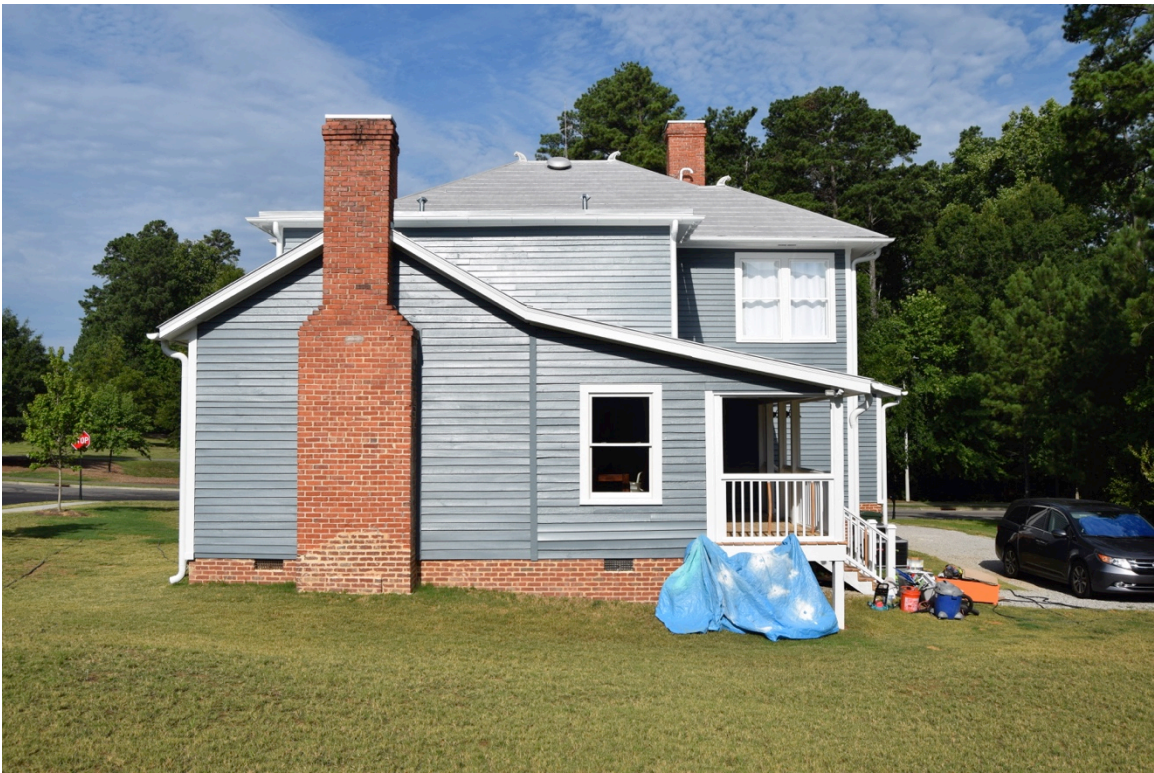
John L. and Henrie G. Sears House, rear elevation, view W

The Sears House appears to have originally included single-story rear rooms, likely under a shed roof, that housed the butler's pantry and first-floor bathroom. The gabled building appended to the back of that section was probably an older dwelling or farm building on the land, repurposed as the kitchen at the time of construction. This accounts for the continuous weatherboards on the south wall. Also, the roof of the gabled kitchen and the front porch were originally the same pressed tin seen at the main block of the house. The current metal roofing at the kitchen and porch were installed after the move, in 2018. A vestigial cornerboard at the rear elevation of the kitchen marks the original width of that structure, which may have been intact when the house was built. If so, it likely had an open porch on its north side, making the doorway from the back of the stair hall a back door that opened directly

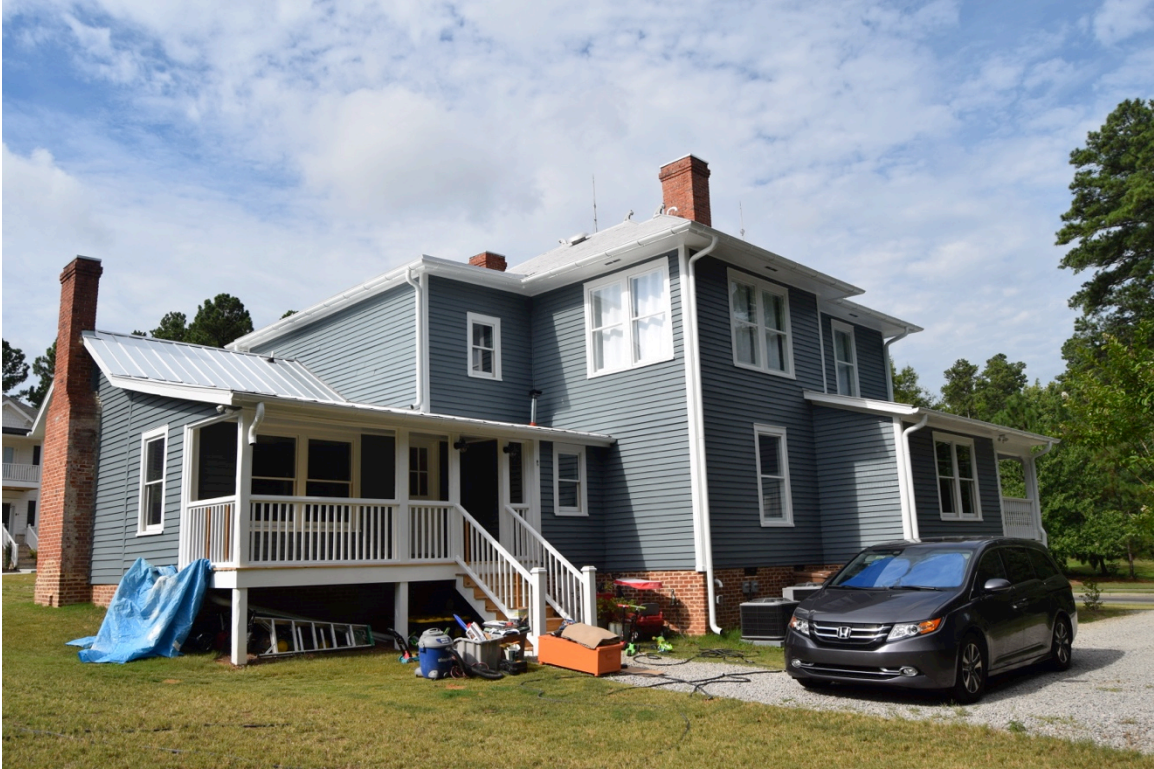
John L. and Henrie G. Sears House, N elevation, view SW

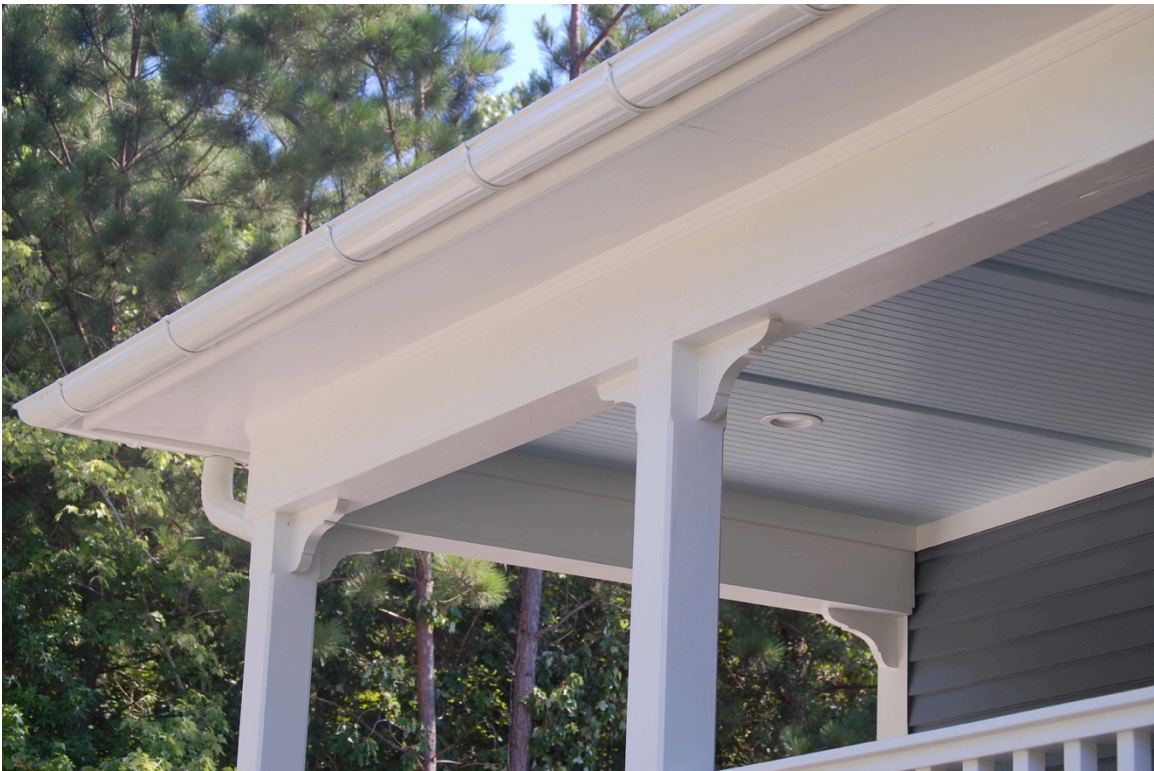
John L. and Henrie G. Sears House, porch posts and brackets, viewNE

Photographs from previous Wake County architectural surveys can help date a few changes. Today's chamfered-edge square porch posts and brackets appear to be faithful reproductions of common historic types. The front porch posts were missing altogether in architectural survey photos from 1989. Notes on the form from that survey report that the "porch is being repaired—will have square posts." Square posts were in place by 1992, but railings and brackets came later. Shutters at the façade windows were likewise added between 1989 and 1992. A greenhouse appended to the back of the kitchen at some point before 1989 was removed before the relocation.

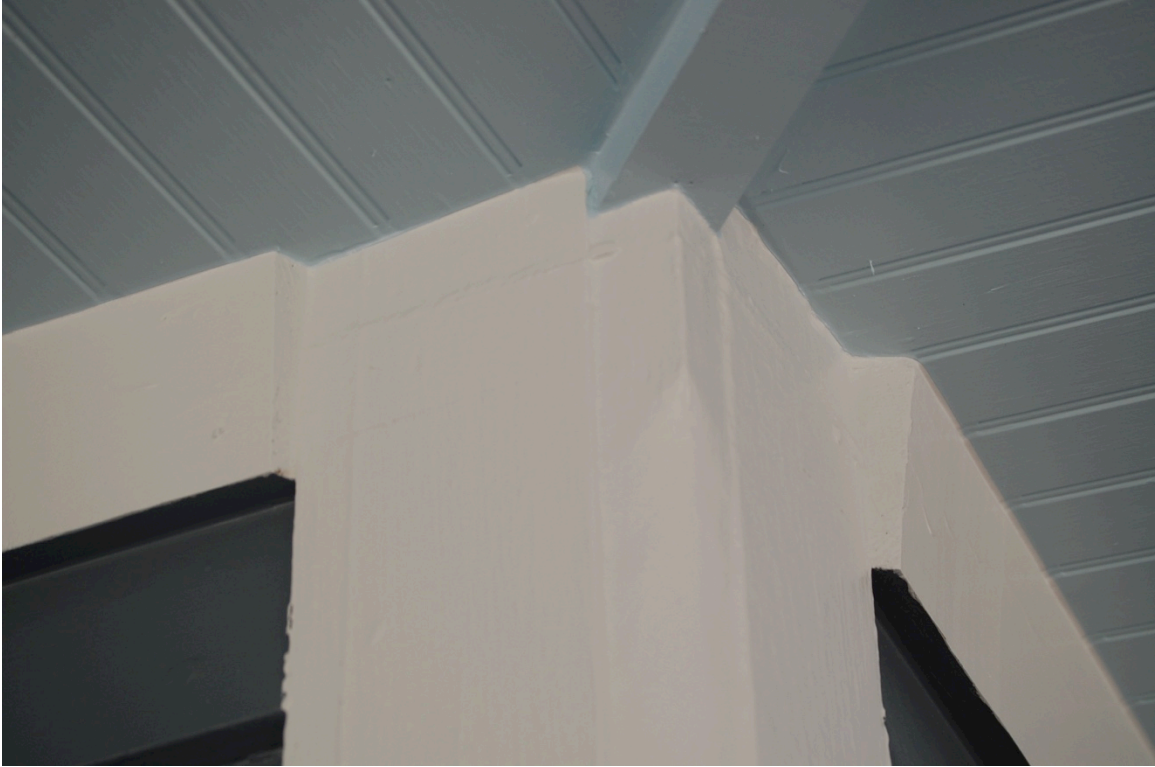
John L. and Henrie G. Sears House, detail at cornerboard, view NE

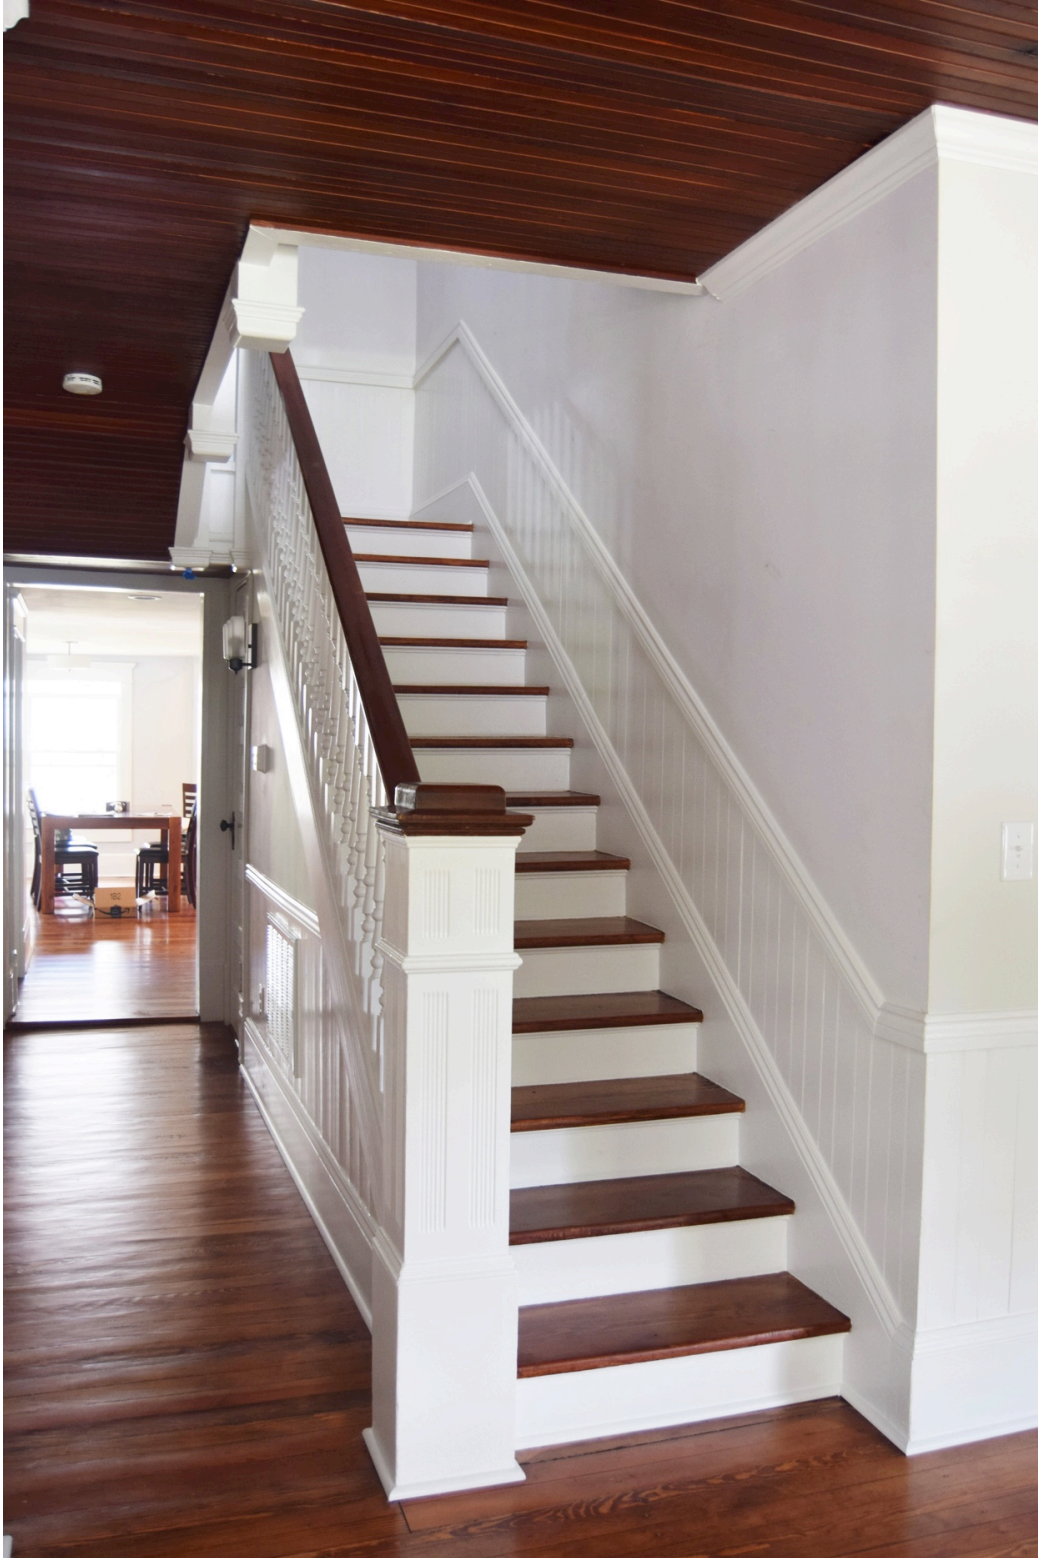
John L. and Henrie G. Sears House, stair hall showing reeded stair newel, view NE

The main feature of the center hall is a closed-stringer stair rising from the front to a landing about three-quarters of the way to the second floor. The stair makes a full turn to complete the rise to the second story. Access to a bathroom is from the first landing. The stair has turned balusters and a substantial square newel with a tall plain base, reeded panels, and a square cap. Smaller versions are at the two landings.

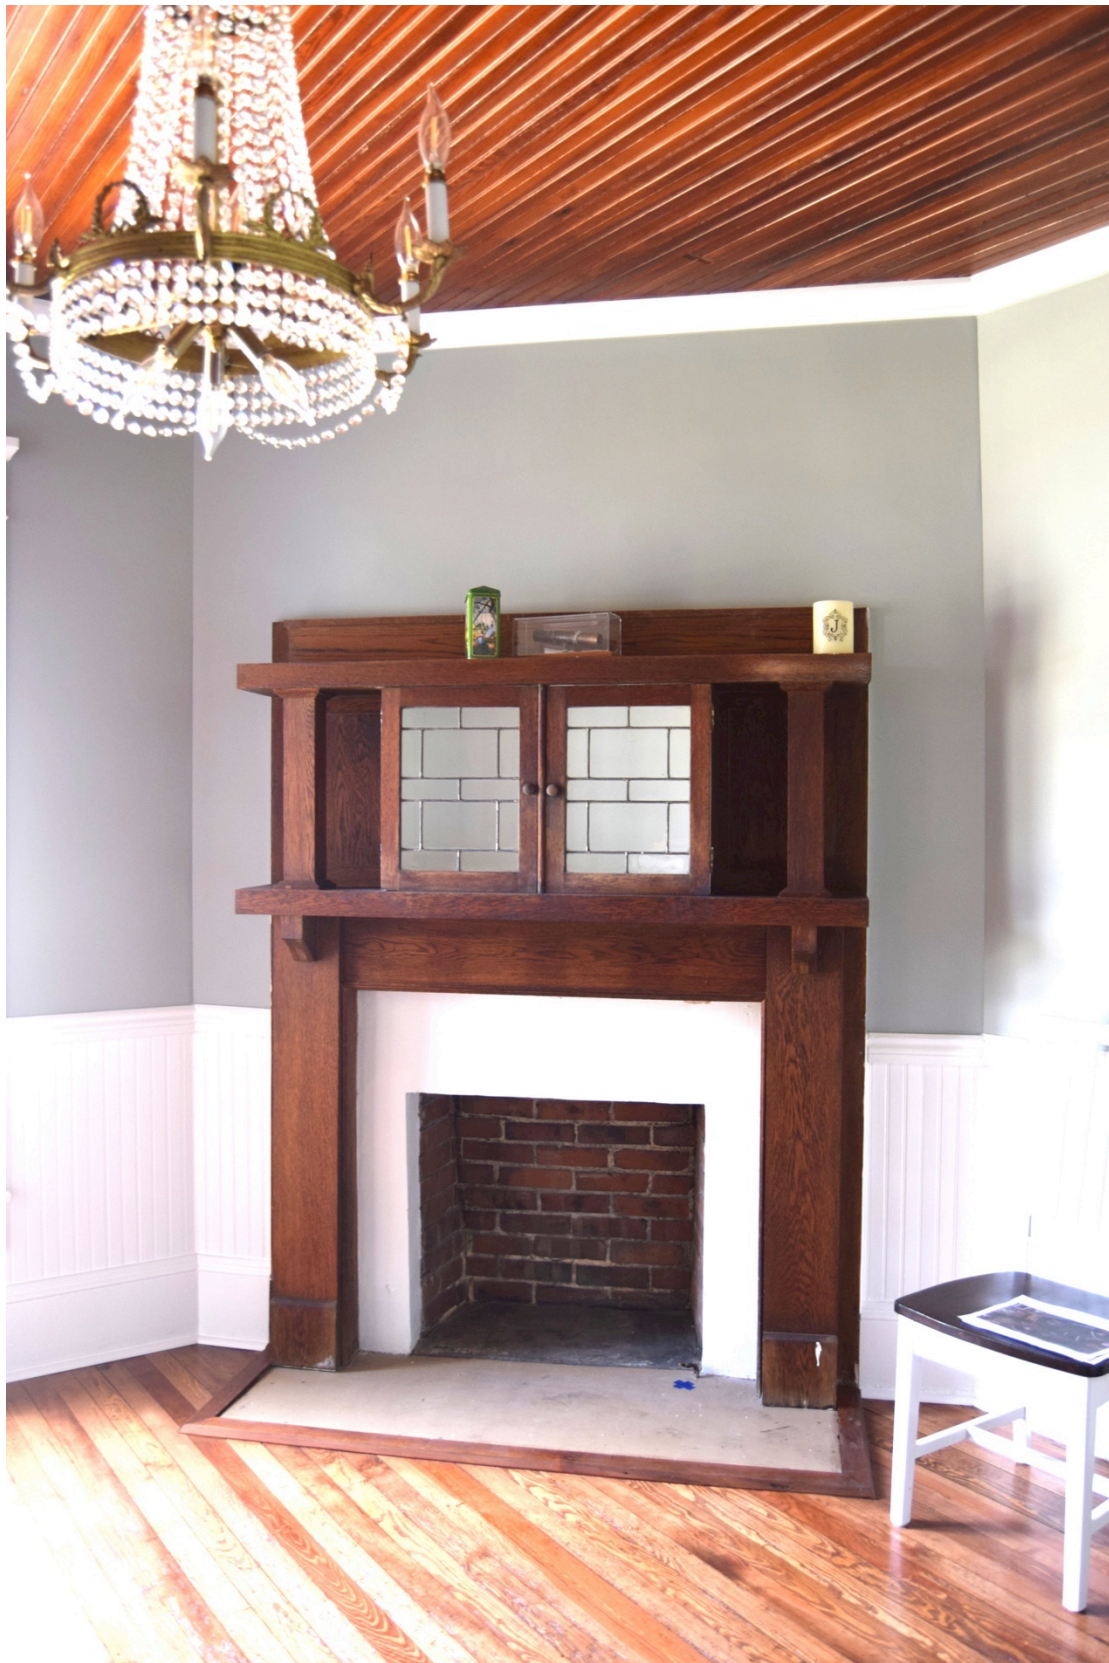
John L. and Henrie G. Sears House, dining room mantel, view SW

The five fireplace mantels include one with Colonial Revival character, two Craftsman examples, and two simplified Craftsman versions. The four at the first floor all have mirrored overmantels. The Colonial Revival-style mantel in the parlor has a thick shelf on deep ogee-molding supported by round columns with simple capitals and bases on high plinths. A molded lintel caps the overmantel. Glazed tile surrounds the firebox and lines the hearth; the mantel itself is painted white. The two Craftsman mantels share the south chimney and are each set into a corner of their respective rooms—the front room that is open to the foyer and the dining room behind it. Both mantels are currently unpainted but had been painted earlier in the twentieth century.¹ The mantel in the front room has plain, bracketed shelves over the mirror and the glazed-tile firebox. Battered pilasters are layered over a flat surround finished at the top shelf with a plain lintel. The ends of faux pegged beams protrude through the pilasters, and a small carved wood cartouche is centered under the lower shelf. There is glazed tile at the hearth as well. The dining room mantel has plain pilasters at the firebox and squared columns at the lower bracketed shelf to support the upper shelf. A cabinet with leaded glass doors sits between the shelves. The fourth mantel at the first-floor bedroom shares the north chimney with the parlor mantel and simply has bracketed shelves. Directly above, the only upstairs bedroom mantel resembles that in the bedroom below but with just a single shelf. Both are painted white.

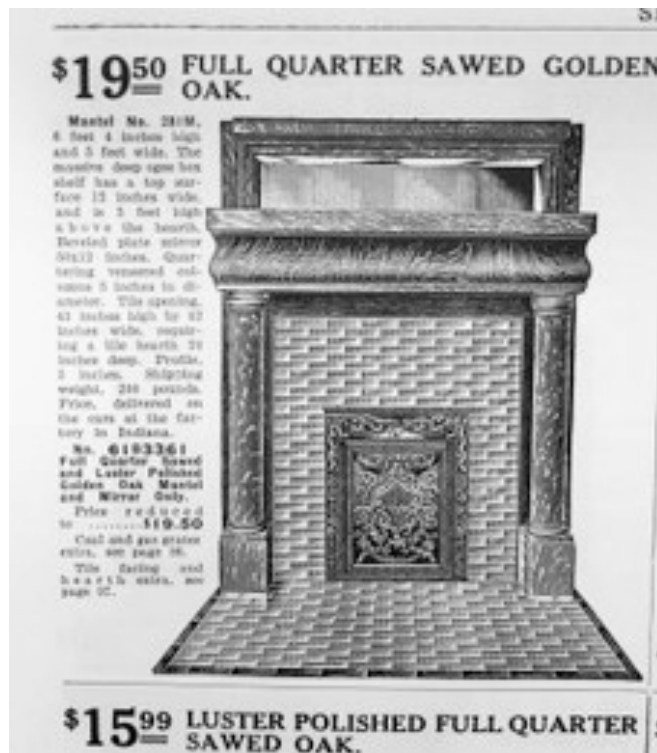
Mantel No. 281M from reprint edition of *Sears, Roebuck Home Builder's Catalog: The Complete Illustrated 1910 Edition*.

Mail-order catalogs also sold all manner of component parts: doors, window sash, trim, wainscot, mantels, and hardware. Sears, Roebuck & Company sold residential building supplies from the catalog as early as 1897. In the early twentieth century, the company had expanded the building materials department and published separate “builder’s catalogs” full of millwork, hardware, plumbing supplies, and more—virtually everything to build-out a framed house. The mantel in the parlor of the Sears House was available as Mantel No. 281M published in the company’s 1910 *Home Builder’s Catalog* and 1912 *Building Material and Millwork* catalog. The model included the quarter-sawn oak mantle with beveled mirror in the overmantel; tile for the firebox and hearth were available separately but shown in the illustration. The catalogs also featured six-panel interior doors in varying dimensions and materials; one-over-one window sash with options for trim, including plain as well as molded drip cap; bronze locksets with round knobs and rectangular escutcheons like those in the house; and all types of molding and trim seen throughout the house. Many of these elements were standard, however, and might have been available from other sources as well.¹²

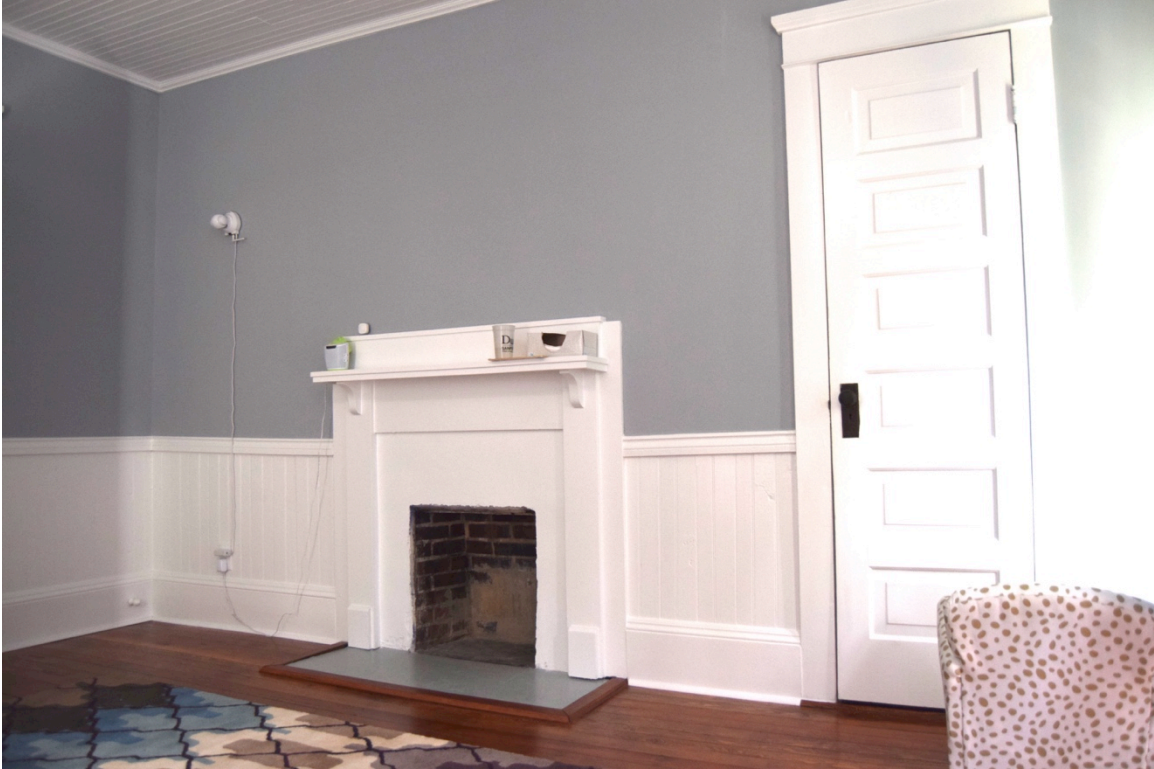
John L. and Henrie G. Sears House, upstairs mantel, view SW

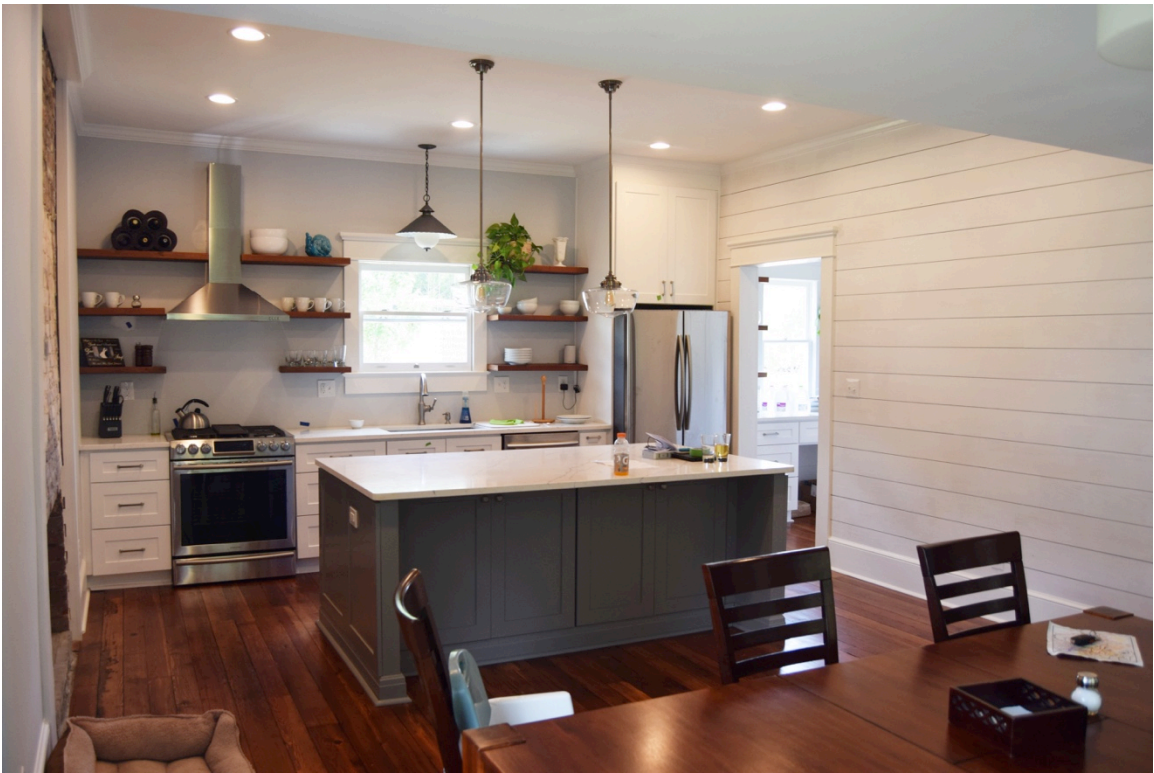
John L. and Henrie G. Sears House, kitchen, view SW

A number of things make it likely that all the work was done at the same time. Windows in the gabled kitchen wing and the front porch enclosure were of the same six-over-six type and scale, common to the late 1960s. If the kitchen was indeed originally smaller, the enclosure of its first porch to make a larger kitchen would likely prompt the replacement of all the windows in into the space. Alternatively, some of the enlargements of interior space may have come earlier and the spaces remodeled in the late 1960s or early 1970s. The cornerboard treatment shown in the illustration was reproduced at the porch enclosures and at the second story of the addition, perhaps an indication that those projects were completed by the original owners.

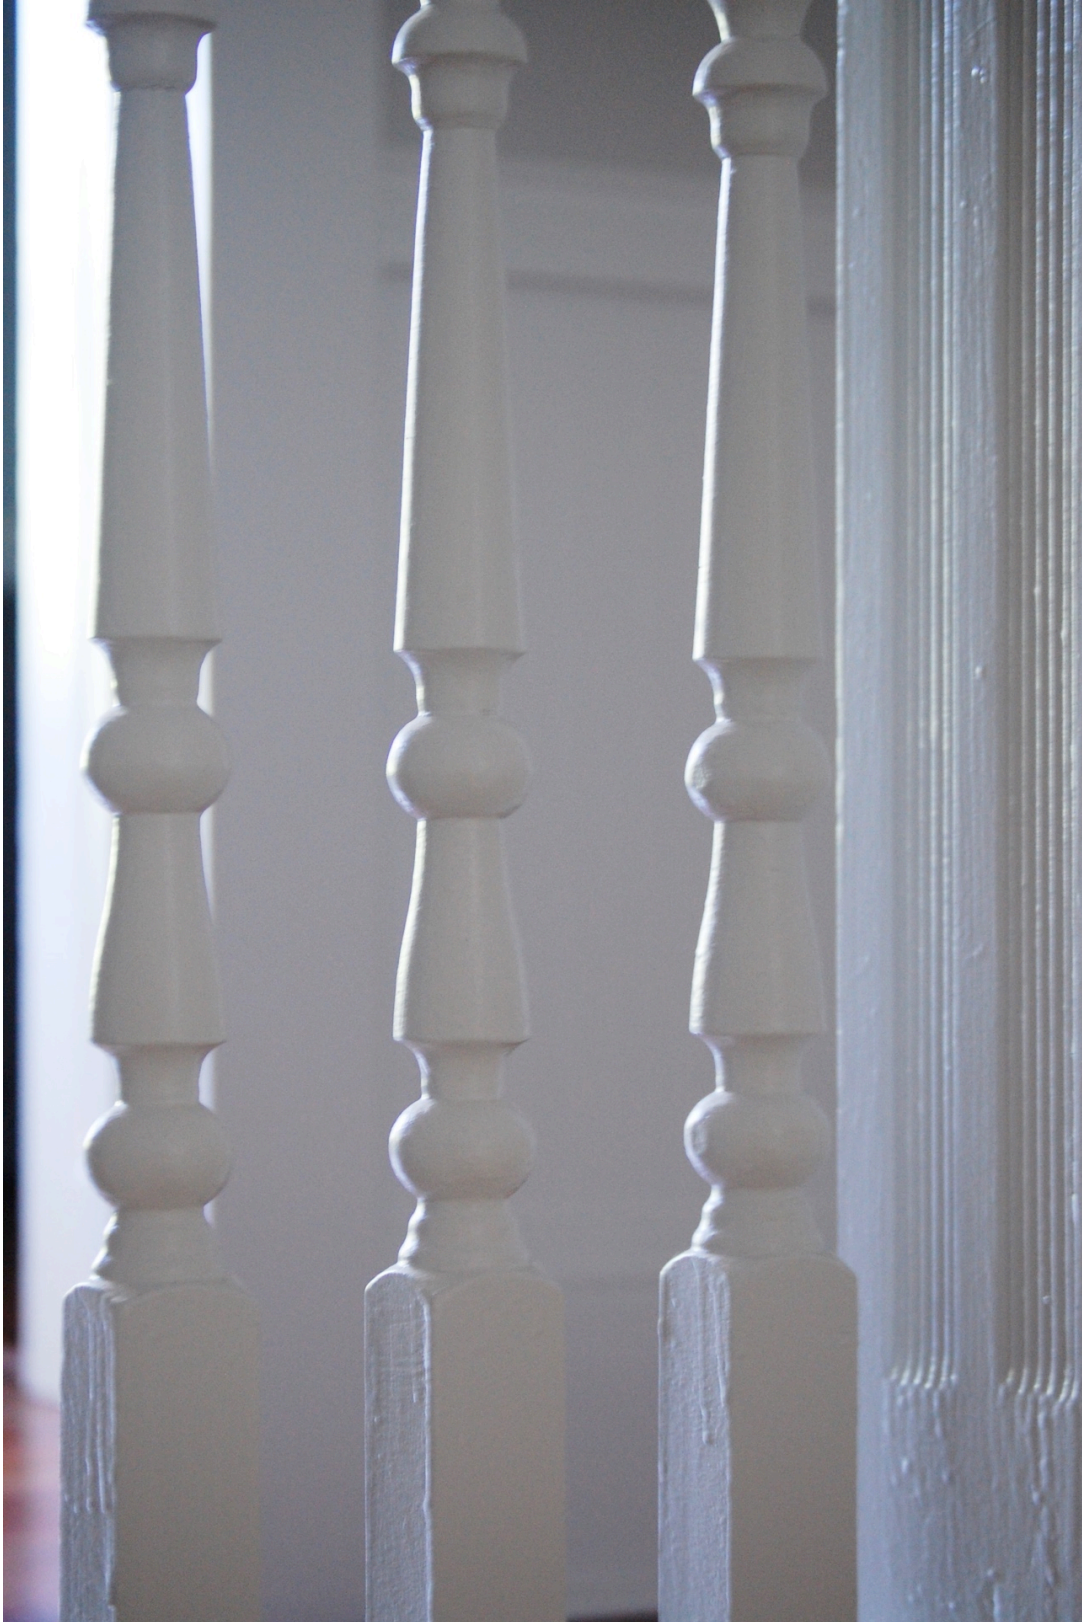
John L. and Henrie G. Sears House, stair balusters, view W
