APPENDIX D

Existing Inventory of Cary's Historic Resources

Inventory of Historic Resources

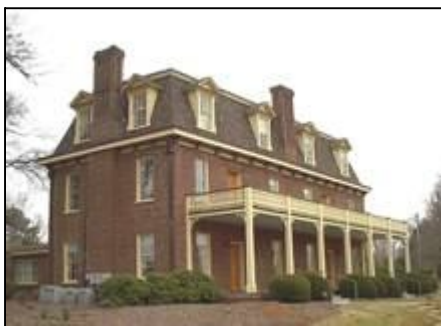
Page-Walker Arts and History Center, 119 Ambassador Loop

1868 with later additions

This is a good example of a Second Empire style building with its signature mansard roof. The building also has Italianate details, particularly the decorative bracketing at the eaves. It served as a railroad hotel and retains the integrity of location and context adjacent to active rail lines.

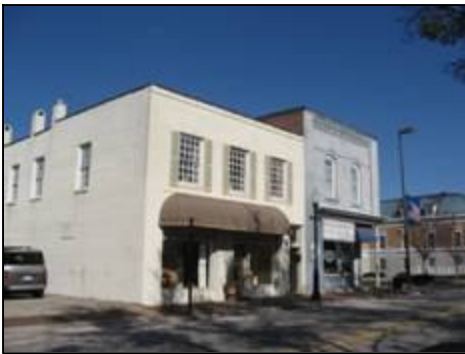
Ashworth Drugstore

This is a two-story, six-bay brick commercial building on a corner lot. Large multi-paned display windows face Chatham Street on the first floor with sash windows above. The building has a parapet roof and a semi-permanent pent roof awning.

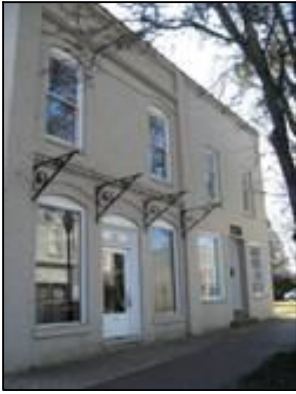
Scott Dry Goods Store, 125-127 West Chatham Street

c. 1910

This pair of buildings is a traditional commercial form—two-story, three-bay masonry buildings with a central entrance and a parapet roof. One-twenty-five West Chatham is the more decorative of the two with round-headed masonry openings topped with rowlock segmental arched lintels, mouse-toothed stringcourses, and a recessed masonry panel with corbelled courses above. One twenty-seven West Chatham has squared masonry openings and a more modest brickwork cornice.

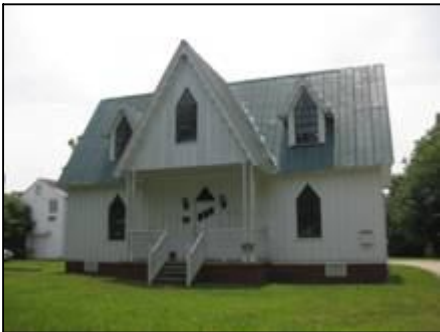
Ivey-Ellington-Waddell House, 135 West Chatham Street

c. 1870

This is a rare surviving example of a Gothic Revival-style dwelling. Lancet windows on the façade in dormers and in a central cross gable echo the triangular light above the door and are hallmarks of the style as is the board and batten construction and the decorative bargeboard in the gables as well as the dormers.

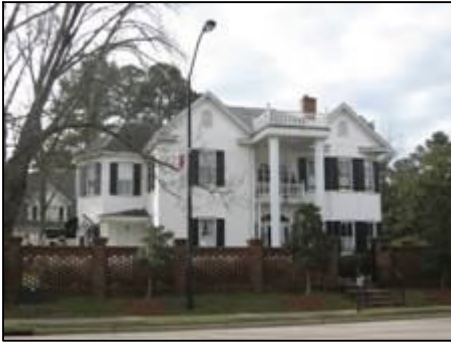
Matthews House, 317 West Chatham Street

c. 1900

This is a two-story three-bay frame dwelling with an irregular plan. It has a hip roof with two, two-story projecting gables on the façade, one of which is a canted bay. A central entrance is dominated by a monumental porch supported by two-story Doric columns supporting a balustraded roof. Smaller one-story Doric columns set behind the monumental ones support a similarly balustraded balcony over the entrance which is accessed by paired doors.

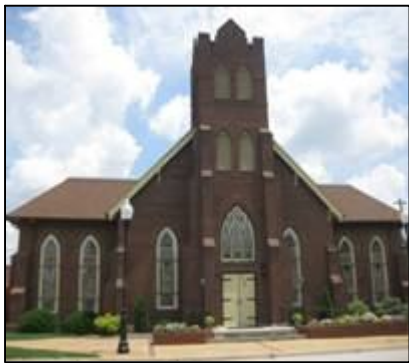
First Methodist Church, 117 South Academy Street

c. 1915

This Gothic Revival church has evolved to serve its congregation. The core of the building is a gabled-fronted, buttressed brick-veneered building with a buttressed and crenellated central entrance tower with double-leaf entrance doors, a lancet-shaped stained glass window with tracery, and two levels of paired lancet louvers. Lancet-shaped stained glass windows flank the entrance tower and are paired in two flanking wings—also buttressed.

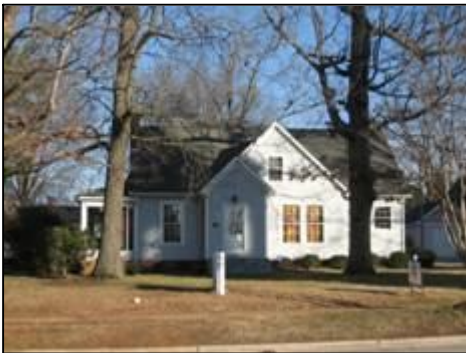
200-208 South Academy Street, blockface entry

This is a blockface entry for several domestic buildings in the 200 block of South Academy Street. The building at 200 South Academy has been demolished. The building at 208 South Academy Street is a one-story frame dwelling with a hipped roof with several hipped roof projections. A one-story three-bay porch is supported by slightly tapered square posts on brick piers. Predominant window style is one-over-one.

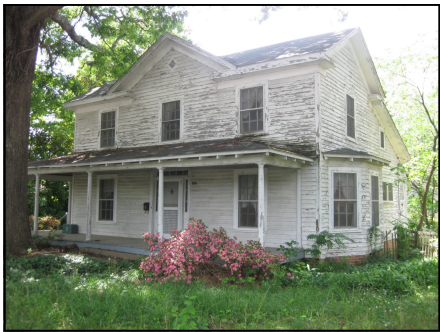
302 South Academy Street

c. 1890

This is an I house with a rear addition. There is a cross gable centered on the façade. A full width, hip-roofed front porch is supported by Doric columns and pilasters. The central single-leaf door is flanked by three-light sidelights with panels below and topped by a multi-light transom. Side elevation has a canted three-sided projecting bay. Windows are generally six-over-six.

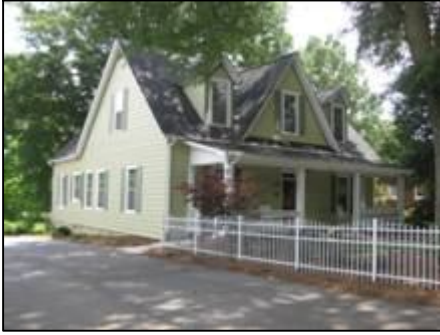
Pasmore House, 307 South Academy Street

c. 1900

This is a one-and-one-half-story three-bay side-gabled frame house with modestly Victorian detailing. A large cross-gable flanked by two pedimented dormers dominates the façade. The three-bay one-story, shed-roofed porch is supported by doric squared posts and pilasters. The single leaf entrance door is in the central bay and is topped by a two-light transom.

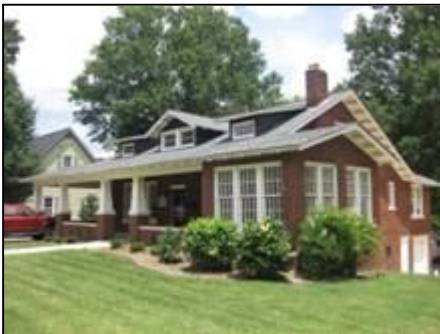
Dr. John P. Hunter House, 311 South Academy Street

1925

This is a one-and one-half-story, side-gabled brick house with a central-pedimented dormer flanked by two shed dormers. The front porch is supported by tapered posts on brick piers; it is enclosed on the south and at the north extends to create a porte-cochere. The roof features exposed rafter tails and there is an exterior end chimney on the south elevation.

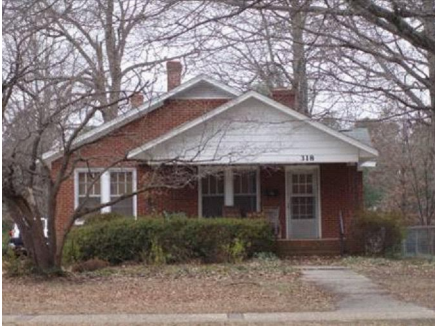
318 South Academy Street

c. 1923; c. 1962

This frame, one-story, gable-front bungalow was completely remodeled around 1962, during which a brick veneer was added to the exterior. The doors, windows, and porch supports were also replaced. The building is non-contributing due to alterations. This property includes a c.1940 one-car garage with a gable-roof, concrete-block walls, and a paneled door. The garage is a contributing building in the National Register District.

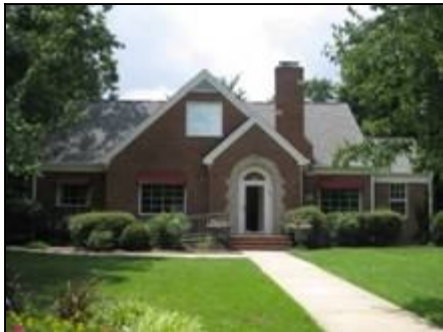
Henry Adams House, 320 South Academy Street

c. 1940

This is a one-and-one-half-story brick, side-gabled house with a projecting cross gable on the façade. Within the cross gable is a smaller offset gabled entrance with a stone arch which houses a single leaf entrance door with a fan light above. An exterior brick chimney with stone accents is nestled against the cross gable.

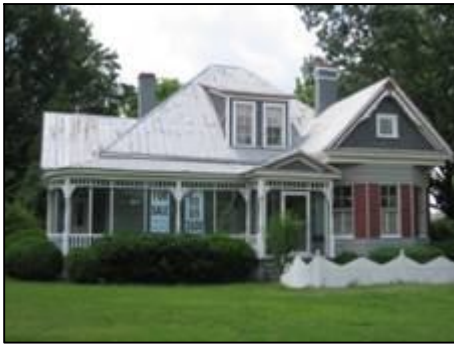
324 South Academy Street

c. 1890

This modest Queen Anne-style house features irregular massing and a composite roof. A spindle frieze, turned posts with brackets and a turned balustrade grace the porch and the front cross-gable has a relatively modest bargeboard. The roof is standing seam metal. The porch has been glassed in.

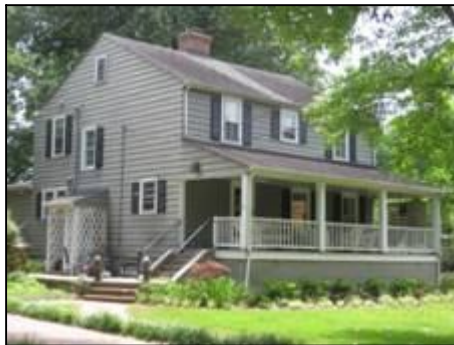
107 West Park Street

c. 1940

This is a two-story, three-bay, side-gabled, frame house that appears to have a side hall plan. A one-story shed-roofed porch spans the façade and is accessed from a side elevation; it is supported by square posts with a square-section balustrade. There is a single central interior brick chimney.

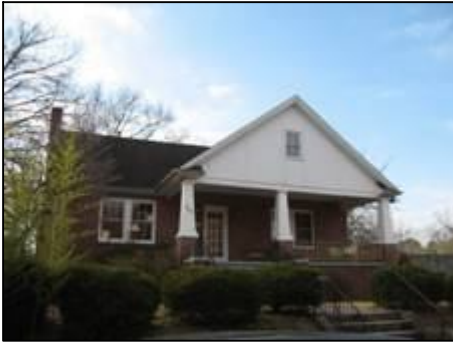
111 West Park Street

c. 1940

This is a one-story, three-bay side-gabled brick Craftsman style dwelling. The entrance flanked by paired six-over-one sash windows. An oversized front cross-gabled porch with a four-over-four window in the pediment is supported by tapered posts on brick piers which shelters a single leaf multi-light entrance door.

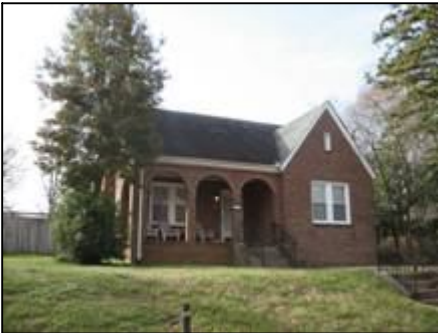
115 West Park Street

c. 1930

This is a one-story, three-bay side-gabled brick dwelling. The inset porch is flush with the front-cross gable. The façade sports paired six-over-six sash windows, one is set on a cross gable and the other is on the porch. A single-leaf entrance is accessed by a porch supported by three-arch brick arcade.

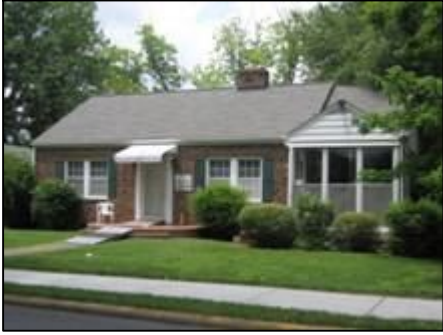
116 West Park Street

c. 1940

This is a side-gabled one-story three-bay brick former dwelling with a gabled telescoping wing fronted by a cross gabled sunporch. Entrance is by a single-leaf front door flanked by paired six-over-six sash windows with soldier course lintels. There is one offset interior chimney.

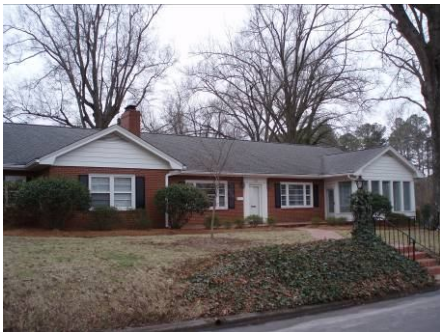
119 West Park Street

c. 1951

This is a Colonial-revival-influenced brick ranch house. When the Cary National Register District was established in 2001, this house was listed as non-contributing due to its age.

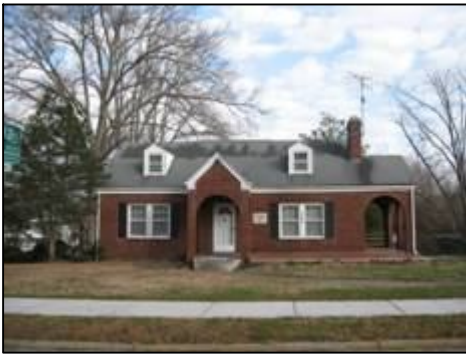
120 West Park Street

c. 1932

This one-and-one-half story, three-bay side-gabled brick dwelling has been converted to institutional use. Entrance is in the center bay by a single-leaf paneled door with integral fan light. A one-bay projecting gabled brick porch with arcaded entrances on three sides shelters the entrance. The building has paired six-over-six windows flanking the entrance and two six-over-six windows in façade dormers. The building has an exterior end chimney and a projecting one-bay brick arcaded side porch.

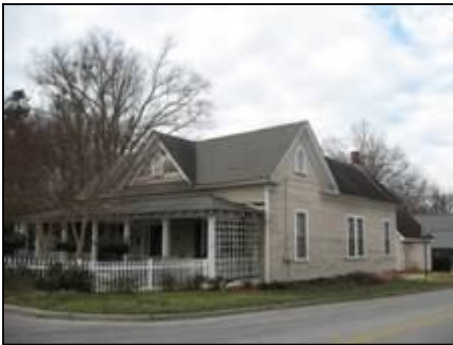
Marcus Baxter Dry House, 400 Faculty Avenue

c. 1900

This is a one-story frame triple A cottage with Victorian details. Central cross gable has decorative shingling and a lancet-shaped louver. One-story hipped roof porch with exposed rafter tail spans the façade. Central single leaf entrance with side lights. Predominant window type is four-over-four.

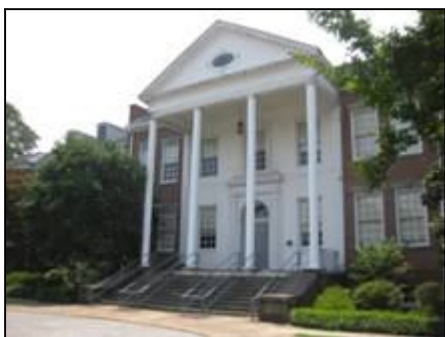
Former Cary High School, 100 Dry Avenue

1940

This Colonial Revival building was once Cary High School and then later served as Cary Elementary. Prominently sited at the terminus of South Academy Street, its monumental classical portico dominates the façade. Slim columns support a modillioned pediment on a broad fascia. Double-leaf entrance doors are within a pilastered door surround with a cornice supporting an elaborate window surround for the central window above.

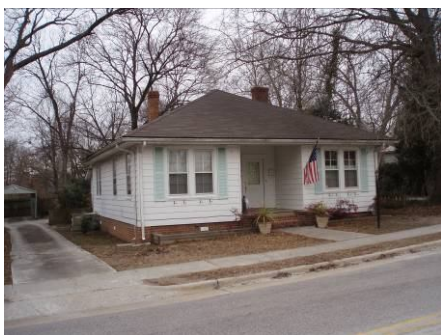
106 Dry Avenue

c. 1920

This is a one-story frame house with a pyramidal roof, four-over-four sash windows, and an interior brick chimney. The recessed front porch has been partially enclosed and the house has aluminum siding.

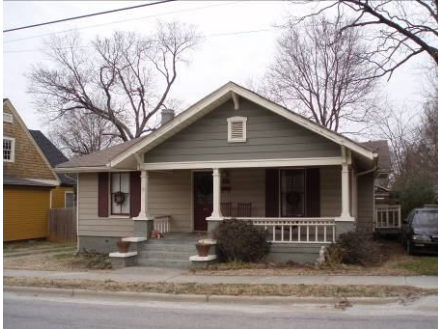
110 Dry Avenue

c. 1930

This frame Bungalow has a hip roof and a gable-roofed front porch supported by square posts on brick piers and a decorative picket balustrade. Windows are two-over-two sash. Alterations include the addition of aluminum siding and the enclosure of the open triangular gable braces.

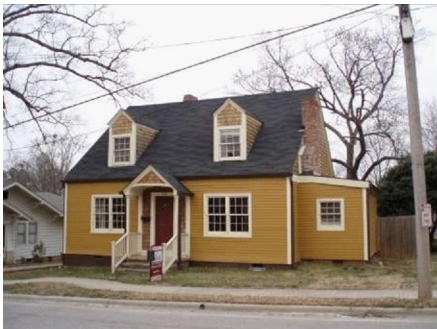
112 Dry Avenue

c. 1930

This is a one-and-a-half-story period cottage with simple Colonial Revival details such as the gabled roof dormers, six-over-six sash windows, and simple gable-roofed entry porch.

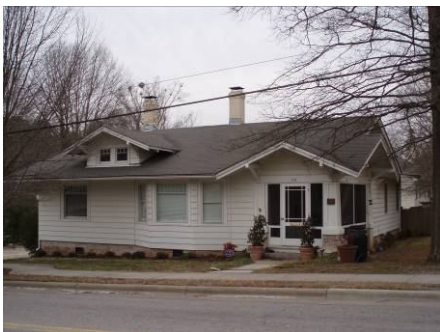
114 Dry Avenue

c. 1920

This is a frame Bungalow with a low-pitched gable roof and a broad roof overhang embellished with triangular brackets. Some windows have been replaced; a few original windows with multi-paned upper sashes over one lower sash remain. The front porch has been screened in and the exterior is covered with aluminum siding.

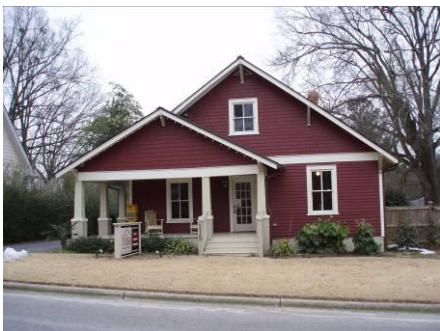
115 Dry Avenue

c. 1923

This is a one-and-a-half story gable-front frame Bungalow with a one-story gable-roofed front porch supported by tapered wood posts on brick piers and triangular brackets in the gables. Windows are two-over-two sash. This property contains a frame, one-car garage with a gable-roof (c.1923). The garage is also a contributing building in the National Register District.

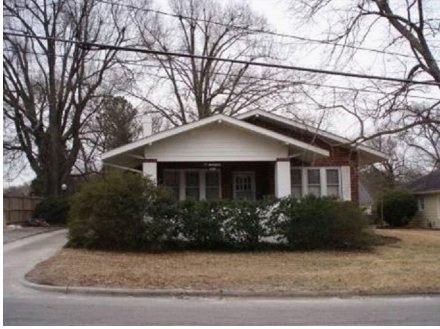
119 Dry Avenue

c. 1922

This is a one-story brick-veneered, gable-front Bungalow with a gable-roofed porch supported by brick piers and enhanced with shingles in the gable. The sash windows are six-over-one. This property also contains a brick-veneered, two-car garage with a low-pyramidal roof (c. 1922) which is a contributing building in the National Register District.

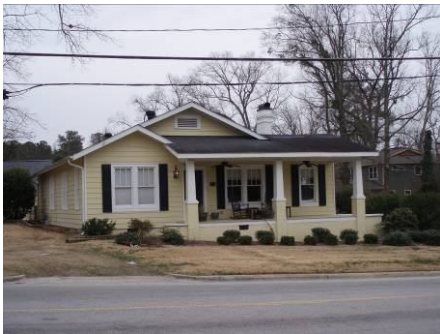
121 Dry Avenue

c. 1930

This is a one-story, frame Bungalow with simple Craftsman details: exposed rafter tails, three-over-one sash windows, and a porch supported by tapered wood posts on brick piers. The exterior is covered with aluminum siding. This property also contains a one-car, frame, gable-roofed garage (c. 1930) with German siding. The garage is a contributing building in the National Register District.

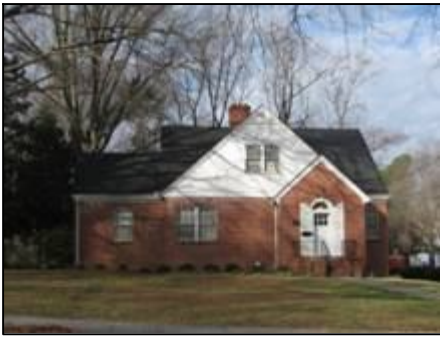
208 South Harrison Avenue

c. 1935

This is a one-and-one-half-story, side-gabled brick dwelling. A slightly projecting cross-gabled wing on the façade has frame siding in the pediment with a louvered vent in the peak of the gable and paired six-over-six windows. Projecting slightly from the cross-gabled wing is an offset gabled entrance with a single leaf door with a fan light above with double leaf louvered shuttered doors that are round-headed. A side gabled telescoping wing extends the façade.

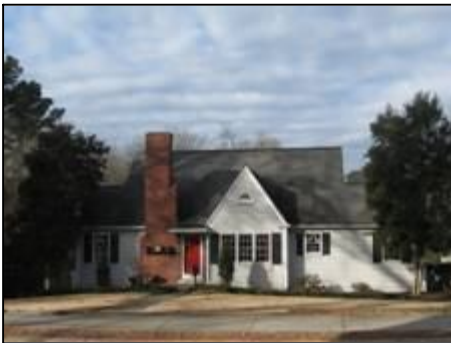
302 South Harrison Avenue

c. 1941

This is a one-story, five-bay side-gabled frame dwelling clad in asbestos shingles. The outer two bays are extending wings with a lower pitched gable. The center bay is a projecting gabled bay with triple six-over-six sash windows with a four-light lunette in the gable. Entrance is by a single leaf door with three cascading lights. Adjacent to the entrance is a brick exterior chimney with offset shoulders.

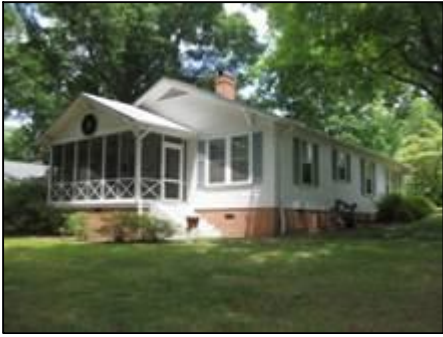
307 South Harrison Avenue

c. 1930

This is a one-story, front-gabled, frame Craftsman style house. It has an offset gabled projecting screened porch with a decorative railing. Porch and building roofs have decorative knee braces. Windows are generally six-over-one.

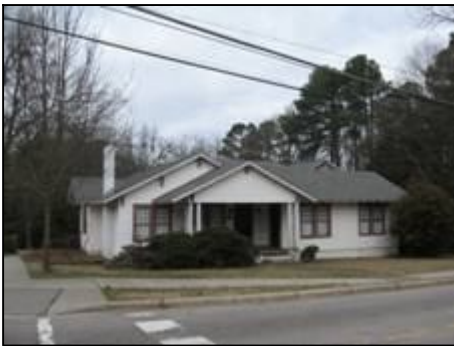
326 South Harrison Avenue

c. 1922

This is a one-story frame cross-gabled Craftsman-style house clad in aluminum siding. Roofs have exposed rafter tails and decorative knee braces. Entrance is via a single-leaf door sheltered by a projecting gabled porch supported by two sets of three square posts. The predominant window type is nine-over-one.

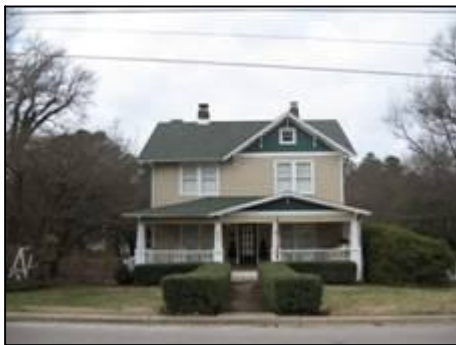
400 South Harrison Avenue

c. 1926.

This is a two-story frame Craftsman style house. It has a side-gable roof with an offset projecting front gable with decorative shingles. A full-width hipped roof front porch on tapered posts on piers also has a front cross-gable aligned with that above and also with decorative shingles, but shallower in pitch. All roof structures have decorative knee braces.

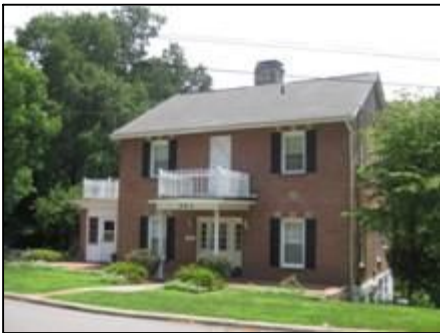
Former Dairy Farm Buildings, 301-303 South Dixon Street

PIN 0764208378, SSN WA0927

1930

This building at 301 South Dixon, along with a massive tile and masonry barn located on an adjacent parcel at 303 South Dixon, are part of a former dairy farm. Both are now residences. The residence at 301 South Dixon has handsome brick detailing with stone accents; the former barn at 303 South Dixon has equally handsome brick and tile structural polychrome, topped with a standing seam metal gambrel roof.

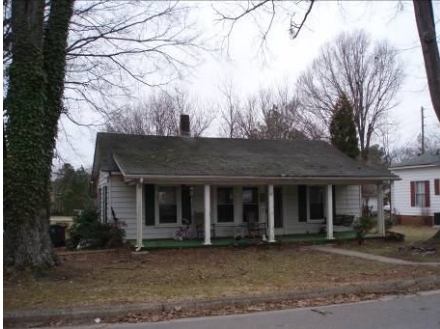
207 N. West Street

PIN 0764312892

c. 1925

Windows were replaced in 2005.

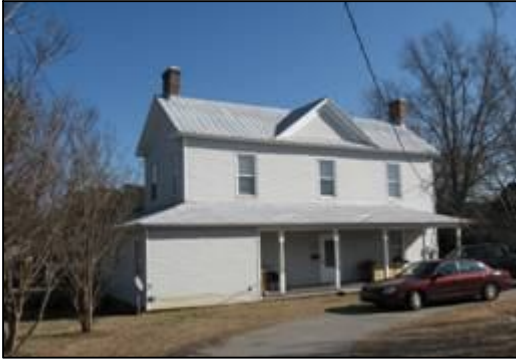
Breeze House, 413 Kildaire Farm Road

PIN 0763592649, SSN WA0909

c. 1900

This is a two-story three-bay frame I house with a pedimented front gable. It has a porch that extends across the façade and wraps around one side elevation; however, the side portion as well as part of the façade portion are enclosed. The remainder of the porch is supported by turned columns. The porch and house roofs are standing seam metal. There are two interior end chimneys with corbelled caps.

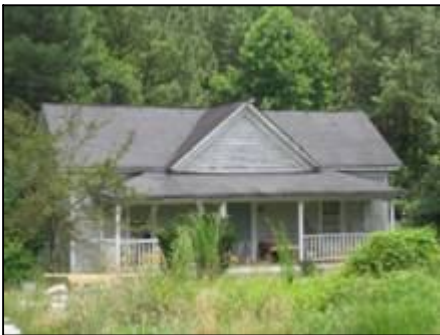
Jones House, 3925 Kildaire Farm Road

PIN 0760064450, SSN WA0663

Deemed not eligible for the National Register

c. 1900

This one-story, triple A cottage was moved to this site from Penny Rd. It has a hipped-roof front porch supported by square posts with a square-section balustrade and rail. One-over-one windows appear to be replacement windows and the house has been re-roofed with synthetic shingles.

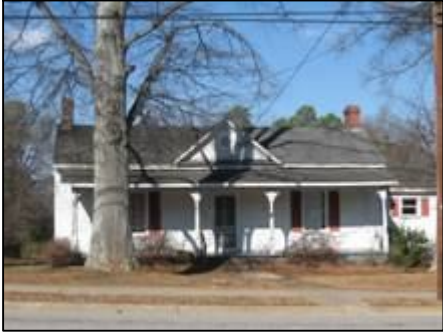
109 and 113 Walnut Street, blockface entry

PIN 0764503144, SSN WA0910

This is a blockface entry for two houses on Walnut Street, however only one, 109 Walnut, remains. This is a one-story, three-bay, frame Carolina triple A house. The central gable on the façade is pedimented with a diamond-shaped louvered vent. Two six-over-six sash windows flank a single-leaf entrance. There are two interior end chimneys with corbelled caps and a three-bay, shed-roofed front porch supported by turned posts with decorative brackets.

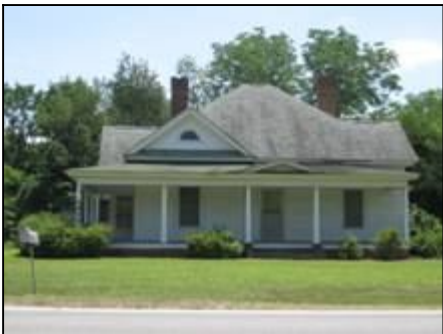
Franklin-Jones Farm, 6405 Holly Springs Road

PIN 0772638831, SSN WA1292

Deemed not eligible for the National Register

c. 1917

This one-story frame, hipped-roof house has numerous cross gables including an offset pedimented front gable with a lunette window. A hip-roofed wrap porch is supported by slender tapered posts and has a pedimented gable to mark the principal entrance which is by a single-leaf door.

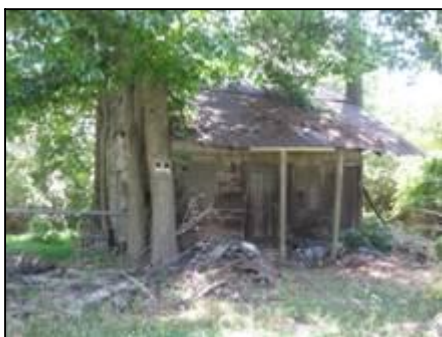
Franklin House (behind 6405 Holly Springs Road)

PIN 0772638831, SSN WA1293

Deemed not eligible for the National Register

c. 1850

This coastal plain cottage is one-and-one-half stories and constructed with a mortise and tenon frame. It is severely deteriorated. The front door is two-panel, and framed openings are covered with louvered shutters. The side-gabled roof is standing seam metal.

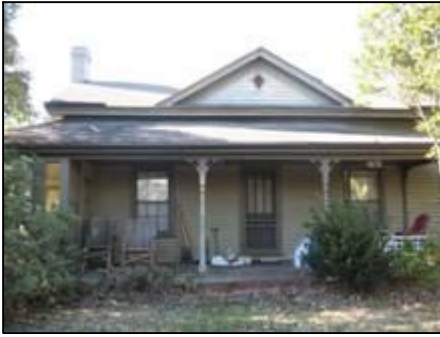
Utley-Pierce House, 9100 Holly Springs Road

PIN 0760454338, SSN WA 0603

Deemed not eligible for the National Register

c. 1860

This one-story side-gabled cottage with a front cross gable has modest Victorian trim on a vernacular hall-and-parlor-plan house. A full-width front porch is supported by turned posts with brackets. The house has had numerous side and rear additions.

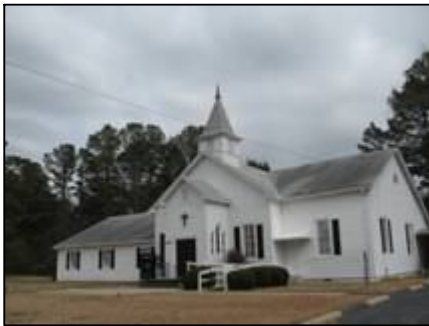
Piney Plains Christian Church, 2803 Piney Plains Road

PIN 0772256782, SSN WA0684

Deemed not eligible for the National Register

c. 1900

This church building has evolved over time with various additions. The central core of the building is a gable-fronted mass with an enclosed projecting, gabled entrance porch. A modest pyramidal steeple with a finial rises from a squared, louvered base on the central gabled core of the building. The church has been sheathed in synthetic siding. There are a few lancet windows but the majority are four-over-four.

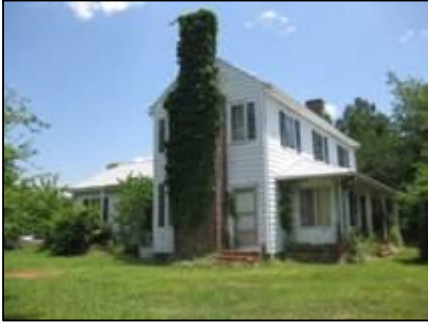
Barnabas Jones House, 9701 Penny Road

PIN 0761939036, SSN WA0679

Deemed not eligible for the National Register

1840

This Greek Revival-style I house has a hipped roof porch that spans the façade (and has been enclosed), two exterior end chimneys, and a rear ell. It is sheathed in synthetic siding. It is on a large tract and is well-screened from the road.

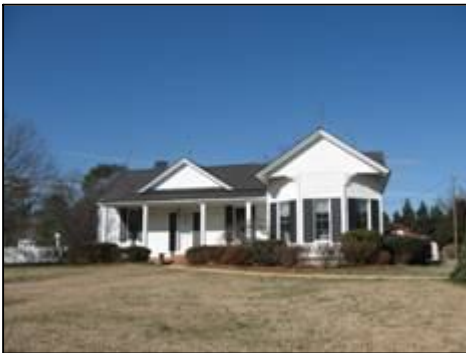
Theo Jones House, 10100 Penny Road

PIN 0761741941, SSN WA0678

Deemed not eligible for the National Register

c. 1900

This one-story, T-shaped, frame Queen Anne house has a projecting cross-gabled wing with a canted bay front with carved brackets. A one-story porch spans the façade to the ell and fronts a pedimented cross gable. Windows are predominantly four-over-four. Porch columns appear to be replacements.

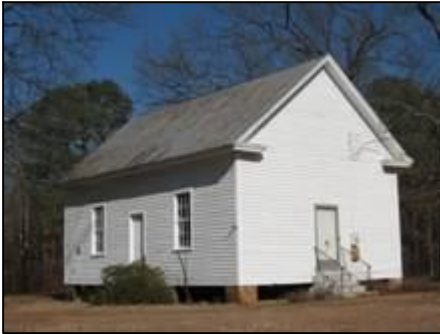
Oak Grove Primitive Baptist Church, 10530 Penny Road

PIN 0761353666, SSN WA0677

On HPO study list

c. 1870

This is a one-story, one-bay, frame gable-fronted chapel. The gable roof has cornice returns. The side elevation has six over six windows. The chapel sits on brick piers. The roof is standing seam metal. The entire structure is remarkably intact. The associated graveyard is now incorporated into a neighboring church's property.

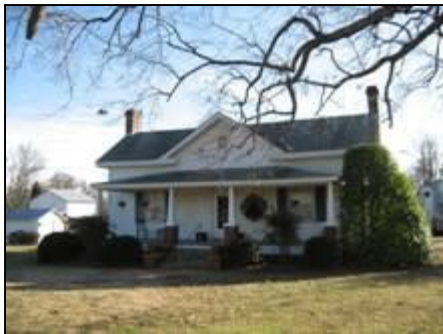
Bell-Pierce Farm, 5508 Ten Ten Road

PIN 0770426721, SSN WA1252

Deemed not eligible for the National Register

c. 1900

This is a one-story, three-bay, frame triple-A cottage with two exterior end chimneys, a full-width hipped roof front porch supported by tapered posts on brick piers. The property also contains numerous outbuildings.

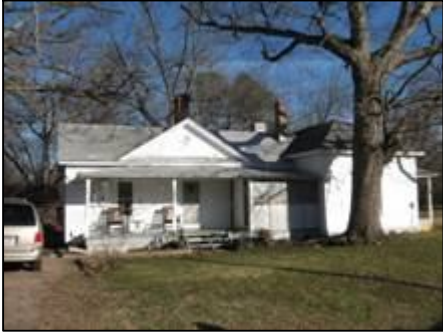
3401 Arthur Pierce Rd

PIN 0760370980, SSN WA0662

Deemed not eligible for the National Register

c. 1850

This is a one-story, frame evolved vernacular house. The original core of the building is a four-bay structure with a low hipped roof. The triple-A section was added later, around 1900. As such, the house has dual facades, though the later portion seems to house the principal entrance. Both have one-story full-width porches.

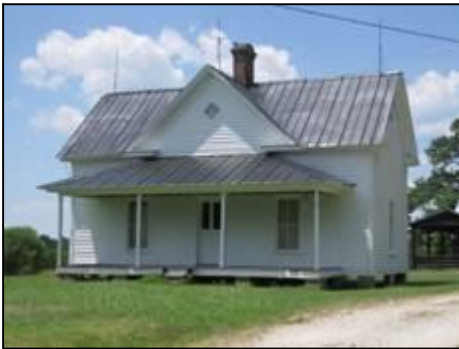
Wes Jones Farm, 8600 Pierce Olive Road

PIN 0760608421, SSN WA0601

Deemed not eligible for the National Register

This site has a complex of late-nineteenth- and early-twentieth-century houses and outbuildings, some of which appear to have been moved to this location. Pictured is a one-and-one-half-story side-gabled house with a front cross gable and hipped-roof porch. The house has two-over-two double-hung sash windows.

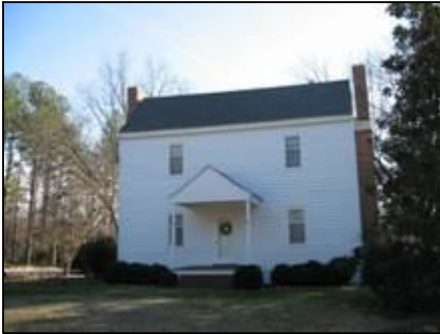
Utley-Council House, 4009 Optimist Farm Road

PIN 0669951842, SSN WA0599

Listed on the National Register

c. 1820

Two-story, three-bay, side-gabled frame Federal period house. The house has two exterior end chimneys, and six-over-nine windows on the façade. Entrance via a single leaf six paneled door sheltered by a single story single bay porch with gabled pediment supported by square posts. Roof material has been replaced with synthetic shingles.

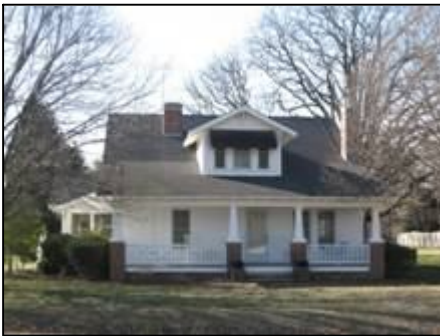
8532 Manns Loop Road

PIN 0679448573, SSN R141 WA04770

Deemed not eligible for the National Register

c. 1920

A good example of a Craftsman Bungalow, this house has many features typical of the style including exposed rafter tails, decorative knee braces and a porch supported by tapered posts on brick piers. The gabled front dormer has two narrow one-over-one windows flanking a larger one-over-one.

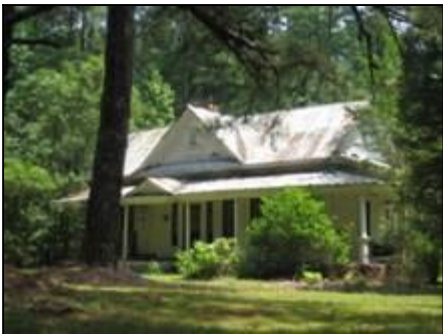
2506 Trenton Road

PIN 0775610860, SSN WA R135

Deemed not eligible for the National Register

c. 1890

This one-story side-gable Carolina triple A house has six-over-six sash windows, wrap-around porch, and sidelights framing a single-leaf front door. The hipped roof porch has a pedimented gable below the cross gable of the house. The gable ends of the house are pedimented as well.

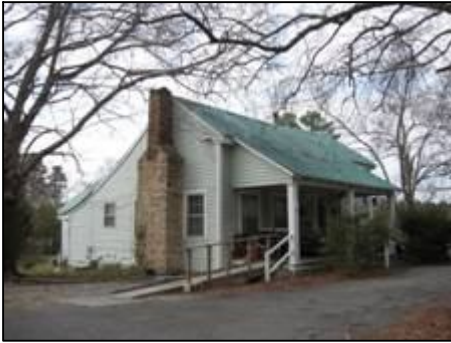
Will Sorrell House

1605 North Harrison Avenue

PIN 0765747695, SSN WA0734

c. 1840

This is a one-story, side-gabled, frame building with Federal and Greek Revival characteristics. A two-bay front porch is supported by square posts and its roof continues the slope of the roof on the primary structure. An impressive stone and brick chimney remains with some signs of deterioration. According to survey data, in 2005 a log outbuilding was removed by grass-cutting crew without owner's permission.

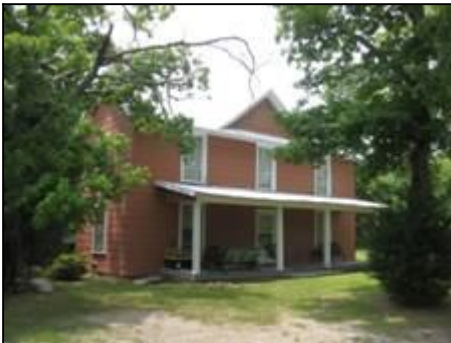
John McGhee Farm

1619 North Harrison Avenue

PIN 0765859357, SSN WA0733

c. 1900

Deemed not eligible for listing on the National Register

This is a Carolina triple-A I house. Windows are predominantly four-over-four. A shed-roofed porch nearly spans the façade and is supported by square posts.

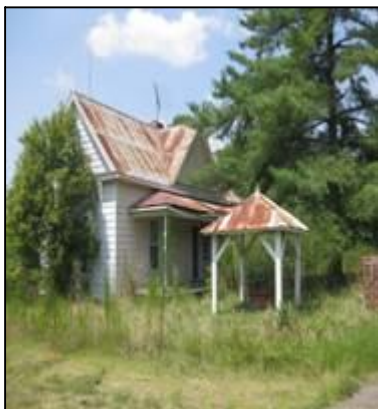
Nelson Rd.

PIN 0757766175, SSN WA0936

Deemed not eligible for the National Register

c. 1900

This Carolina triple-A cottage has a hipped-roof porch across the façade, supported by slender columns. The house retains a standing seam metal roof. In the yard is a well with a hipped standing seam metal roof on square posts with diagonal bracing.

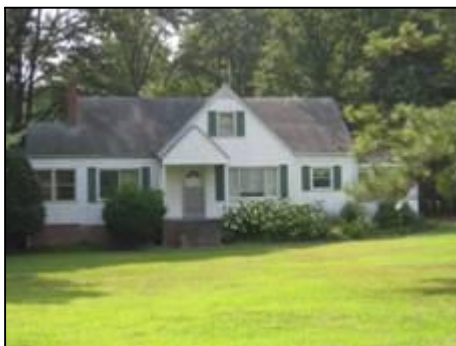
2824 Campbell Rd.

PIN 0772841351, SSN WA-R137

Deemed not eligible for the National Register

c. 1940

This period cottage has a side-gabled roof with a cross gable on the façade that itself has an offset projecting gabled porch. Adjacent to the porch in the cross gable is a three-part picture window. The house has wings on each side elevation—one a projection of the existing side gable, the other a telescoping smaller volume.

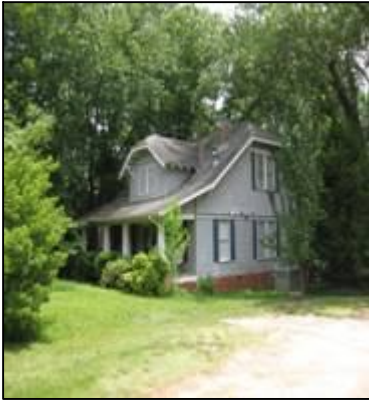
237 Adams Street

PIN 0764333088, SSN WA0884

c. 1925

This is a one-and-one-half story, three-bay frame Craftsman Bungalow with a side jerkinhead roof. A jerkinhead dormer is centered on the façade. A full-width, shed-roofed porch extends from the principal roofline and is supported on tapered wooden posts. There is shingling above the second floor and the roofs have decorative exposed rafter tails and knee braces.

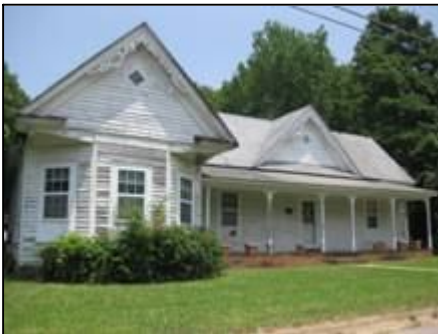
213-232 Hillsboro Street, blockface entry

PIN 0764317867, SSN WA0923

Deemed not eligible for the National Register

This is a blockface entry for several domestic buildings in the 200 block of Hillsboro Street dating from 1900-1925. The building at 226 Hillsborough Street is an amalgam of a Carolina triple A house with an added projecting, canted cross-gabled addition. Both façade gables have diamond-shaped louvered vents and decorative bargeboards in various states of repair.

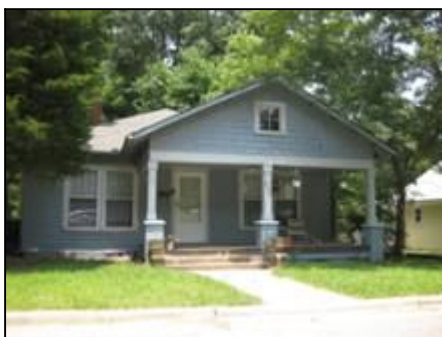
302-306 Wood Street, blockface entry

PIN 0764320324, SSN WA0925

Deemed not eligible for the National Register

c. 1920

This is a blockface entry for several houses on Wood Street. The building at 306 Wood Street is a Craftsman-style house. It has a hipped roof with a projecting cross-gabled porch on the façade. Exposed rafter tails on both roofs are obscured by gutters. Windows are generally four vertical lights over one sash, with a square four-light window in the gable peak. The porch is offset and supported by handsome Doric posts.

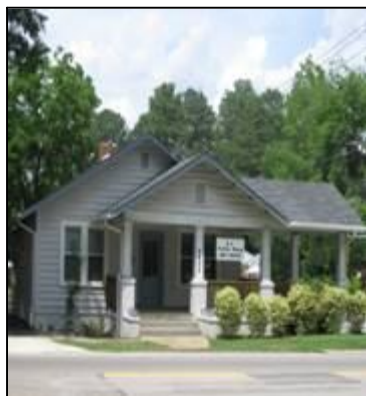
8600 Chapel Hill Road

PIN 0764431277, SSN WA0883

c. 1925

This is a one-story, Craftsman-style Bungalow. A gable-fronted façade has an offset gable-fronted porch supported by tapered square posts on brick piers. What appears to have been a porte cochere on the east elevation now shelters a handicap ramp that climbs along the east elevation to meet the porch. The ramp railing continues along the porch.

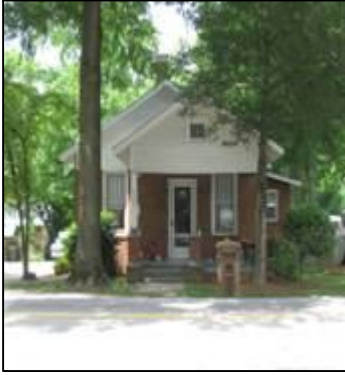
8602 Chapel Hill Road
PIN 0764431277, SSN WA0883
c. 1925

This is a one-and-one-half-story frame Craftsman-style house with brick veneer on the first story. An offset front-gabled porch projects from the front-gabled façade and is supported by tapered posts on brick piers. There is a four-vertical-light window in the peak of the gable. The roof sports rafter tails, and windows include four-vertical-lights-over-one sash.

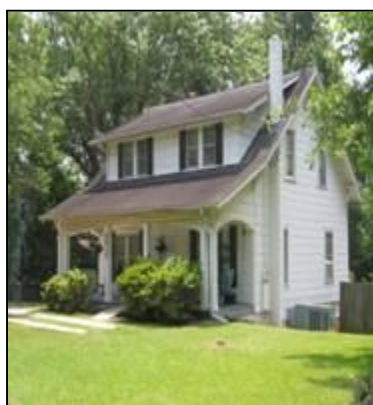
8635 Chapel Hill Road

PIN 0764332193, SSN WA0884

This is a Craftsman-style Bungalow with a large shed dormer containing two sets of paired six-over-one windows. The first floor façade features paired six-over-six sash windows flanking the entrance. The house features decorative knee braces and a three-bay front porch with posts supporting a shallow arched entrance with arches on the porch's side elevations as well. There is an exterior masonry chimney/chase that pierces the primary roof.

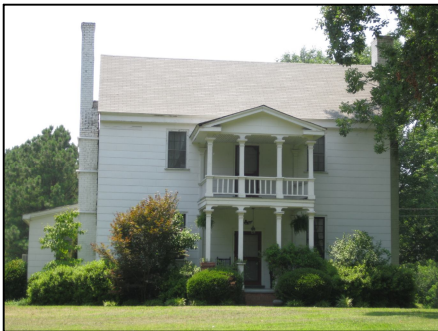
Nancy Jones House, 9391 Chapel Hill Road

This Federal period home features a central two-tiered portico with unusual carved blocking between Doric posts and the fascia or pediment they support. Fenestration is drawn close to the central portion of the façade and windows are nine-over-nine sash. The house was a stagecoach stop and tavern on the route from Raleigh to Chapel Hill and Hillsborough during the antebellum period.

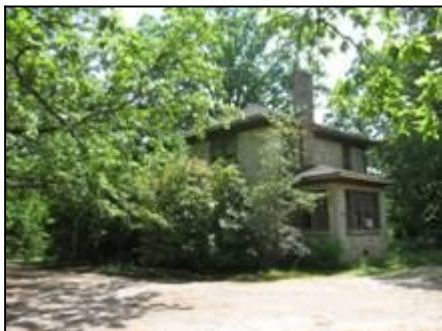
Richards House, 9475 Chapel Hill Road

This is a two-story, hipped-roof, stone, American Foursquare Craftsman-style house. A one-bay porch supported by tapered stone piers shelters the entrance and extends to create a porte cochere which is balanced on the opposite elevation by an enclosed sun porch. Windows are paired and the entrance is a single-leaf Craftsman-style multi-light door with full height Craftsman-style sidelights.

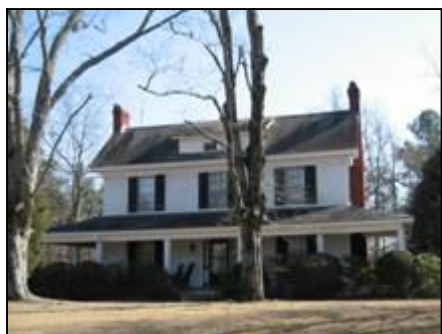
G.H. Baucom House, 2421 High House Road

This is a Greek Revival two-story, three-bay, frame, side-gabled I house with two exterior end chimneys, one-story wrap-porch with squared Doric posts and shed roofed central dormer. It has six-over-six windows and a single leaf entrance with side lights.

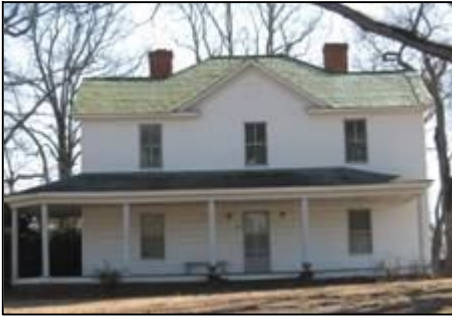
George Upchurch House, 6101 Collins Road

Triple-A I-house with elevated central portion of the gable ridge. Windows are two-over-two. Original entrance door with dual rounded lights remains. House has twin central interior chimneys and a half-wrap porch with replacement columns. House has been resided with synthetic siding.

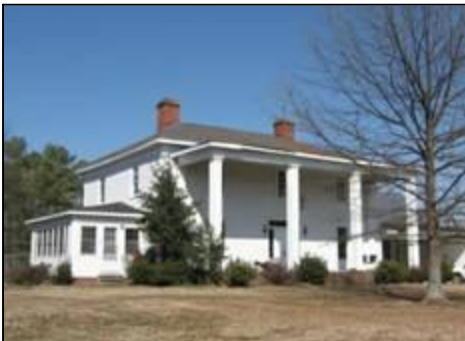
Maynard-Stone House, 2420 Davis Drive

This frame Greek Revival-style house has a two-story, three-bay central core with a hipped roof and a full-width, two-story porch supported by monumental squared columns and pilasters. The core also has generous cornerboards and a broad frieze. Two interior central brick chimneys are symmetrically placed just off the ridge line. The entrance door is flanked by multi-light sidelights and topped by a multi-light transom.

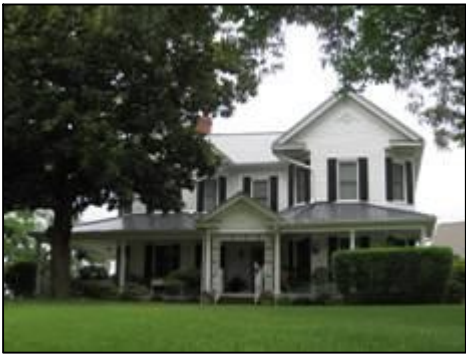
James A. and Myrtie Edwards Farm, 2737 Davis Drive

This early 20th century farm has Queen Anne features. Two projecting cross-gabled bays of unequal distance from the façade frame a central entrance distinguished by a one-story, one-bay pedimented feature with decorative cast iron inserts that interrupts a wrap porch. The farm is directly adjacent to a recent subdivision that impairs its context and integrity of setting.

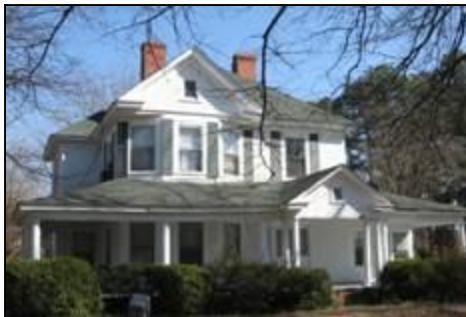
Luther Barbee House, 2836 Davis Drive

This modest Queen Anne house has irregular massing and a composite roof that features a cross gable in the façade with cornice returns that tops a bay-fronted projecting mass. There is a shed roofed wrap porch on Doric columns which also has a gable-fronted entrance with cornice returns. The single leaf front door is flanked by sidelights with paneling below.

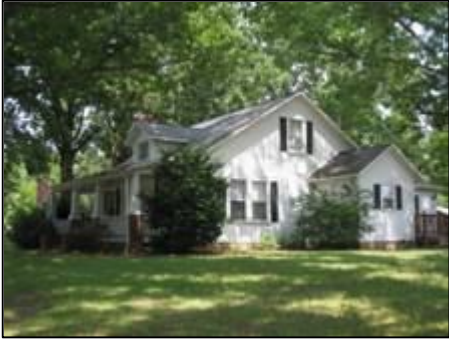
1524 Jenks Carpenter Road

This house is a good example of a Bungalow with its hallmark side-gabled roof, gabled central dormer and inset porch supported by tapered columns of brick piers. It retains its tin-shingled roof and the dormer window has a lattice light pattern.

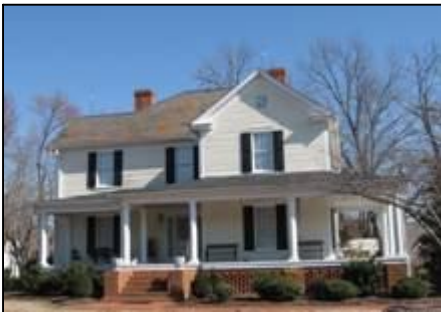
Merrimon Upchurch Farm, 1600 Jenks Carpenter Road

One of two prominent Upchurch family houses situated on adjoining parcels along Jenks Carpenter Road, the dwelling on the Merrimon Upchurch farm is probably the later of the two. The two-story, L-plan house with hip and cross gable roof and two rear ellis has both late Victorian and Greek Revival detailing. Survey data indicates it has been moved.

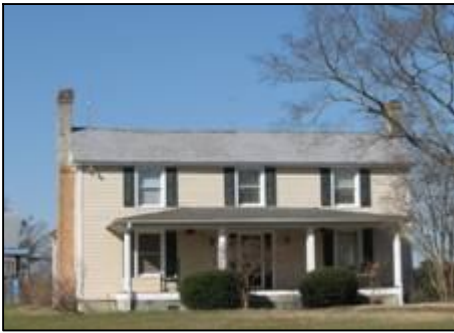
Horton Upchurch Farm, 2000 Carpenter Upchurch Road

This is a Greek Revival I-house at the center of a complex of mostly tobacco-related out-buildings. The two-story three-bay side-gabled dwelling has two exterior end chimneys with corbelled caps. The entrance is a single leaf flanked by sidelights. The roof has tin shingles. The three-bay porch has a hipped roof on square posts and synthetic shingles. The house appears to have been re-sided with synthetic siding and shutters.

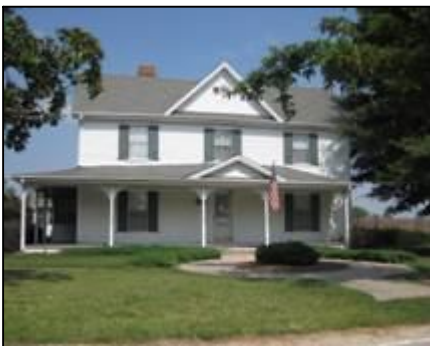
William Henry Carpenter House, 3040 Carpenter Upchurch Road

This I-house has a pedimented cross gable on the façade with a round louvered vent. A hipped-roof wrap porch also has a pedimented cross gable centered on the façade. The porch is supported by turned columns with brackets. The house is now clad in vinyl siding including vinyl shingles in the gable ends. Windows are two-over-two and the house has a later rear addition.

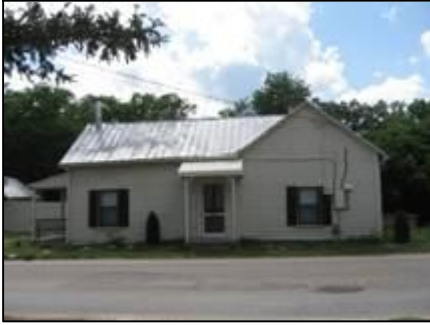
Carpenter Boarding House, 3041 Carpenter Upchurch Road

This vernacular frame dwelling was once used as a boarding house. The cross-gabled roof is standing seam metal. Windows are generally one-over-one. The building draws significance from its context within the Carpenter Historic District and its proximity to the railroad.

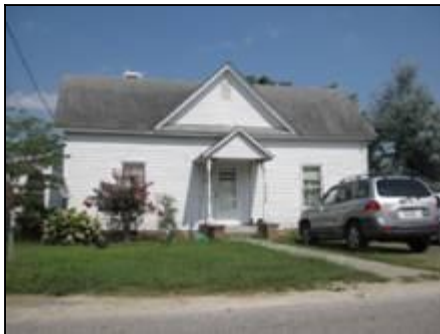
Adelaide Carpenter House, 3048 Carpenter Upchurch Road

This Carolina triple-A house has a pedimented front gable with a rectangular louvered vent. Windows are one-over-one and appear to be replacement. The single-leaf front door is sheltered by a modest gabled portico centered on the façade and supported by slender turned columns and pilasters. There is a shed-roofed addition to the side.

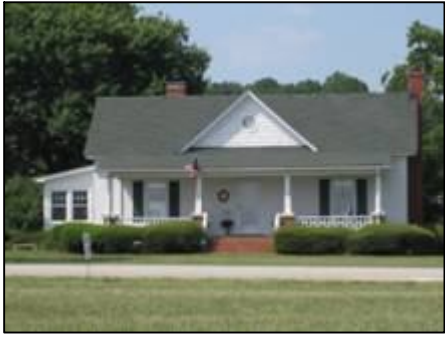
C. F. Ferrell House, 1132 Morrisville Carpenter Road

This is a typical Carolina triple-A cottage. It has a shed-roofed porch that nearly spans the façade supported by tapered posts on brick piers. The railing appears to be recent of a vernacular Chippendale. The pedimented cross-gable has a louvered circular vent and retains decorative courses of wood shingles.

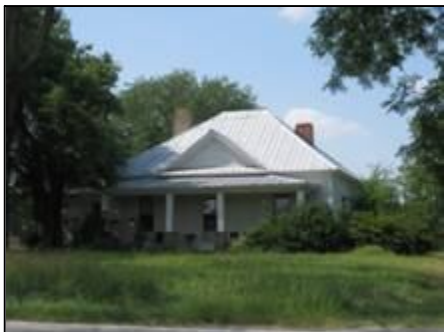
A.M. Howard House, 1580 Morrisville Carpenter Road

This vernacular house, which is part of a larger farm complex, has a steep hipped roof with a gable pediment above a hipped roof porch which is supported by square posts on brick piers. The roofs are all standing seam metal. Two-over-two windows flank the single-leaf entrance centered on the façade. The house is clad in weatherboard and has a handsome broad cornice.

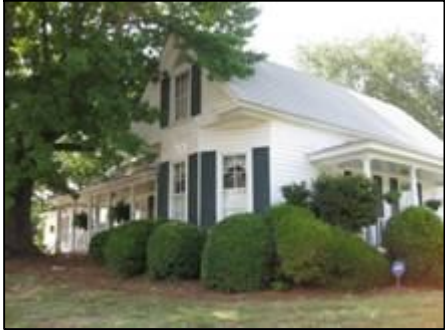
Bill Sears House, 1600 Morrisville Carpenter Road

This house has a traditional form with Queen Anne elements. The cross-gabled house has a pedimented cross gable on the façade with generous cornice returns above a three-sided bay. In the cross gable's ell is a one-story shed-roofed porch that spans the remainder of the façade and is supported by Doric columns. The house sits on the corner lot and has a second open porch on the other street elevation.

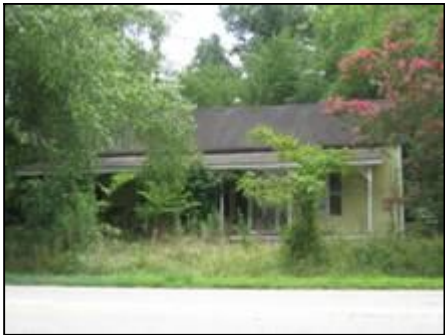
C. F. Ferrell house, 1921 Morrisville Carpenter Road

This modest frame vernacular house has a side-gabled roof and a full-width shed-roofed porch that spans the façade, supported by turned columns with brackets. Interestingly, the façade is not symmetrical and the entrance is off-center.

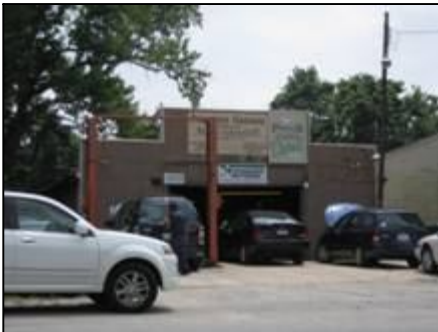
Dodge Car Dealership, Morrisville Carpenter Road

This gable-roofed commercial building has a stepped parapet on the façade. There is a large central entrance to accommodate vehicular access. The area between the building and the right-of-way is paved for additional parking.

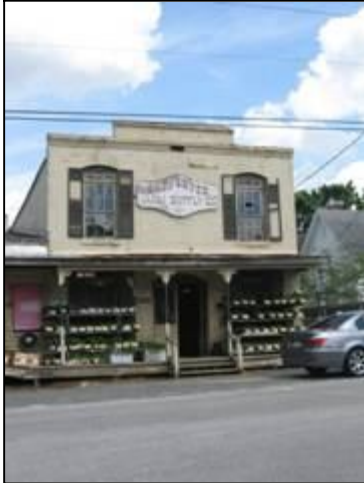
Carpenter Farm Supply Store, 1933 Morrisville Carpenter Road

This is an evolved brick commercial-form building with a frame addition. A shed-roofed porch supported by turned posts unites the façade. The interior of the building is remarkably intact; the building has served as a rural store from its beginning.

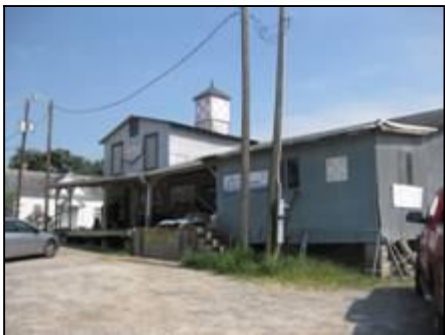
Carpenter Warehouse & Meeting House, 1933 Morrisville Carpenter Road

This is one of the most prominent buildings in the Carpenter District. Located adjacent to the railroad, the building has served an industrial use throughout its history.

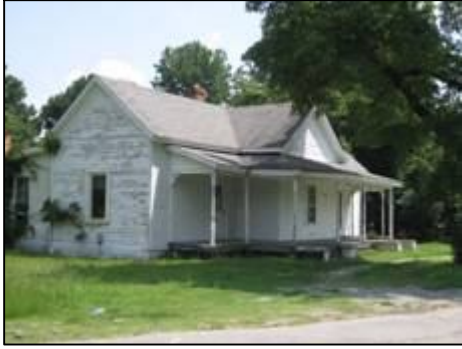
Byrd-Ferrell House, 0 Carpenter Fire Station Road

This modest frame Victorian house has a side-gabled roof and a projecting cross-gabled pavilion centered on the façade. A shed-roofed porch on turned columns wraps the façade and projects to fully accommodate the cross-gabled pavilion. A later shed-roofed addition has been made on the rear.

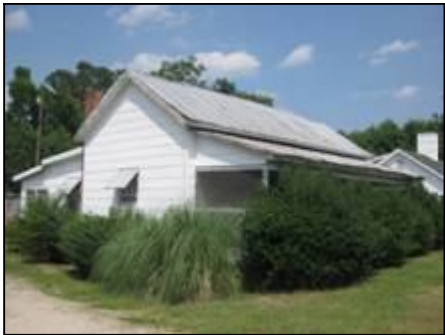
Byrd Tenant House, 0 Carpenter Fire Station Road

One of two similar adjacent tenant houses, this one retains more of its historic fabric. It is a one-story side-gabled house with rear additions and a full-width, screened, shed-roofed porch. The house has standing seam metal roof and is clad in asbestos siding.

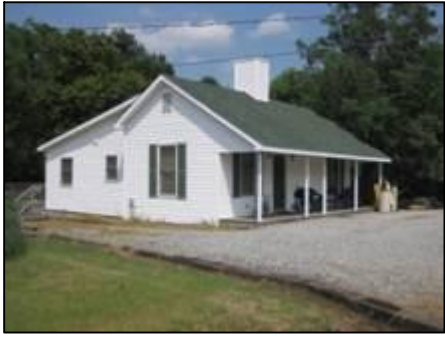
Byrd Tenant House 6716 Carpenter Fire station Road

One of two similar adjacent tenant houses, this one has been greatly altered. The house and its central interior chimney have been clad in vinyl and the roof has synthetic shingles. The shed-roofed porch has been incorporated into the side-gabled roof structure and it is supported by square posts. Windows are replacement one-over-one sash.

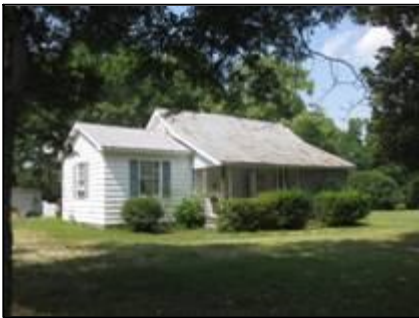
Lemuel Morgan Farm, 7032 Carpenter Fire Station Road

This house has a coastal cottage form with aluminum siding. The 2005 survey update noted new shutters, the smokehouse and log washhouse are gone, and tobacco buildings are overgrown.

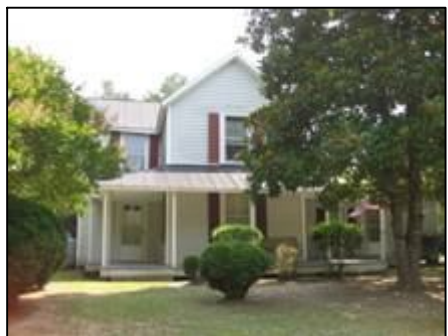
Lorenzo Morgan House, 7225 Carpenter Fire Station Road
PIN 0735341347, WA0965

This two-story vernacular house is side-gabled with a projecting cross-gabled pavilion around which is a one-story, hipped U-shaped porch with a standing seam metal roof supported by slender square posts. Windows are double-hung sash and largely two-over-two.
