APPENDIX D

Existing Inventory of Cary's Historic Resources

Inventory of Historic Resources

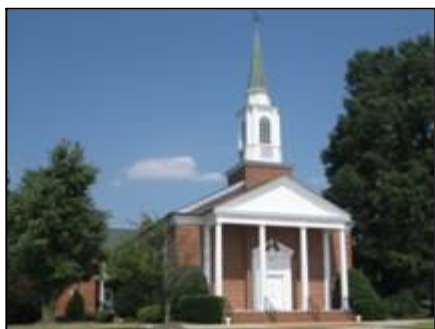
Good Hope Baptist Church, 6636 Good Hope Church Road
PIN 0735858220, SSN WA0746

This Classical Revival church has a monumental pedimented portico supported by four columns and two pilasters. It shelters a double-leaf entrance with a broken pedimented door surround with an urn. The front-gabled church is made of brick and also has a cupola with a spire.

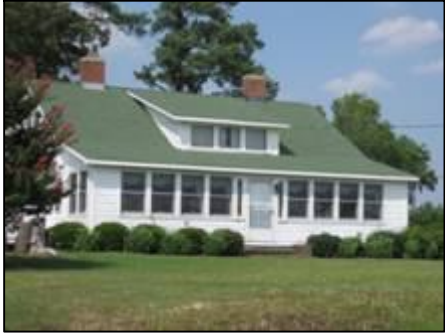
6820 Good Hope Church Road

This Bungalow has an enclosed inset porch with banks of one-over-one windows flanking a central entrance with sidelights. It has a low-slung shed dormer centered on the façade with three single-light windows. It is clad in synthetic siding and has two interior chimneys that pierce the ridgeline of the roof.

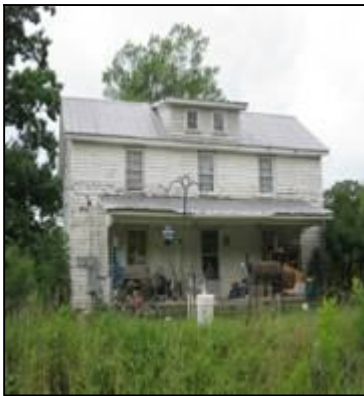
Carpenter-Nutt House, 1629 Petty Farm Road

This is a two-story, three-bay, side-gabled frame I-house with an earlier rear ell. First-story windows are two-over-two and second-story windows are six-over-six. A shed-roofed dormer centered on the façade has been added and it has two four-light windows. A three-bay shed-roofed porch nearly spans the façade; its roof and the primary roof are standing seam metal.

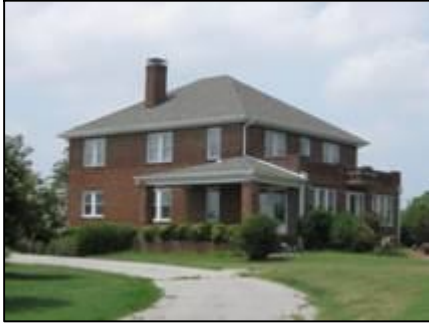
3510 NC Highway 55

This two-story brick Craftsman-style house has a hipped roof and impressive enclosed one-story entrance porch with brick balustrade and balconet. Adjoining the porch is a hipped roof porte cochere on brick piers with a brick planter box.

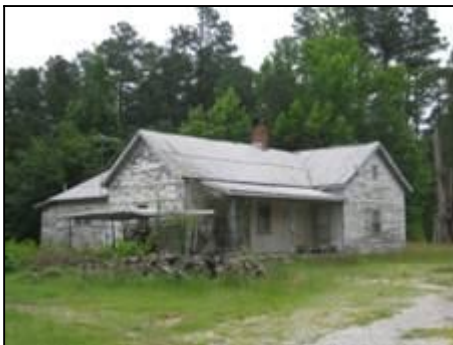
4404 NC Highway 55

This vernacular frame house has an L plan with later additions. The side-gabled roof has a projecting cross gable on the façade, and with the ell is a shed-roofed porch supported by wood trellis columns. The house retains a standing seam metal roof.

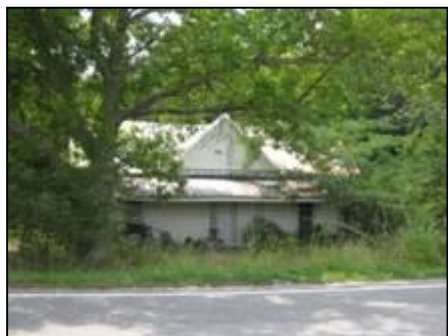
7316 Green Hope School Road

This one-story Carolina triple-A cottage has a pedimented front gable and a shed-roofed porch with modern metal trellis supports. Windows are four-over-four sash. The house retains its standing seam metal roof.

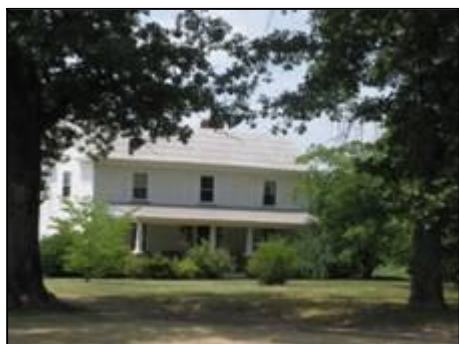
Adolphus Sorrell House, 8626 Manns Loop

This handsome three-bay, side-gabled house is part of a larger farm complex. It has a broad cornice with gable cornice returns and the roof is clad in metal shingles as is the porch roof. The three-bay, one-story, shed-roofed porch is supported by tapered square posts on brick piers. Multi-light side lights flank the entrance.

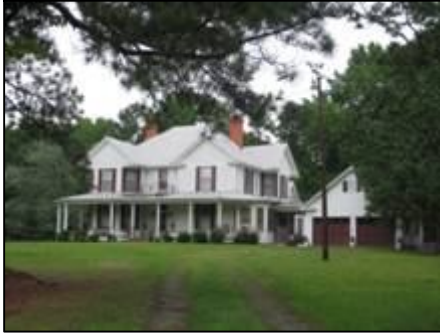
Williams House, 7328 Roberts Road

This is a two-story frame Queen Anne-style dwelling with a hip roof and numerous cross-gabled projecting bays. A one-story wrap porch supported by Doric columns is partially enclosed. An open hyphen connects a garage to a projecting bay on the side elevation. Though synthetic siding has been added to the house, the roof retains its historic metal shingles.

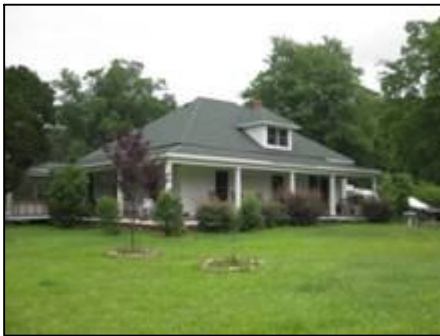
Williams-Roberts Farm, 7416 Roberts Road

This is a one-and-one-half-story three-bay frame dwelling with a pyramidal hip roof and a wrap porch which is supported by classical tapered posts. There is a hipped dormer centered on the façade. The house has numerous outbuildings and is immediately adjacent to a large residential subdivision.

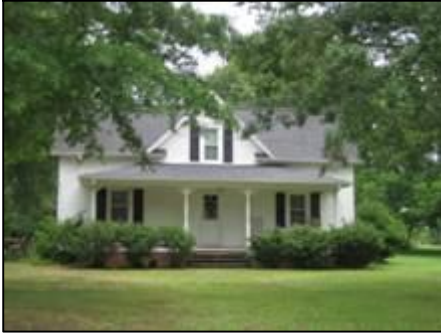
Lassiter-Sloan House, 7612 Roberts Road

This is a vernacular triple-A cottage with two-over-two windows in the cross gable and flanking the entrance. A hipped-roof porch nearly spans the façade; it is supported by turned columns with decorative brackets which appear to be replacements. Both porch and primary roof are synthetic shingle.

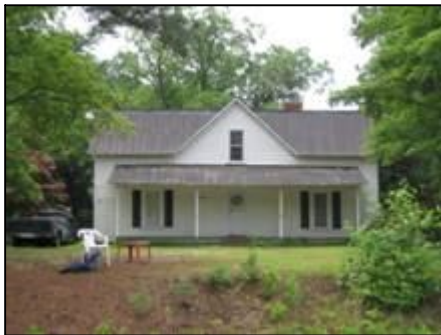
Buck Mills House, 3133 Green Level West Road

This is a vernacular, one-story, three-bay, triple-A cottage. The front cross gable features decorative scalloped shingles. Windows are predominantly six-over-six sash. A shed-roofed porch supported by plain posts nearly spans the façade—its roof and the principal roof are standing seam metal.

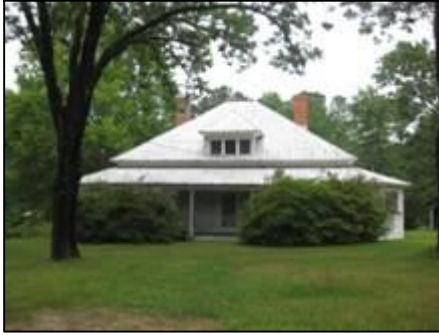
Mills House, 3208 Green Level West Road

This is a one-and-one-half story three-bay frame dwelling with a steep pyramidal hip roof. A wrap porch circles the façade with a hip roof that originates just below the cornice of the primary roof. Both are standing seam metal. Porch posts are squared with necking and support a broad cornice below the roofline. A hipped dormer is centered on the façade and contains three multi-light stained-glass Queen Anne style windows.

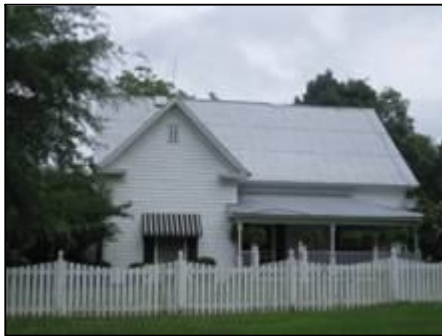
3224 Green Level West Road

This is a one-and-one-half-story, side-gable frame house with front and rear projecting cross gables. There is a two-bay inset front porch; both the porch and primary roofs are standing seam metal. The 2005 Wake County survey update noted synthetic siding and replacement of porch posts.

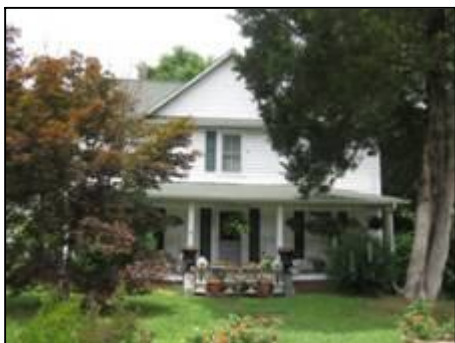
A.C. and Helen Council House, 3608 Green Level West Road

This is a common North Carolina vernacular form, the triple-A house— a two-story, three-bay, single-pile side-gabled I house with a central pedimented cross gable on the façade. Original wood siding has been covered or replaced with synthetic siding.

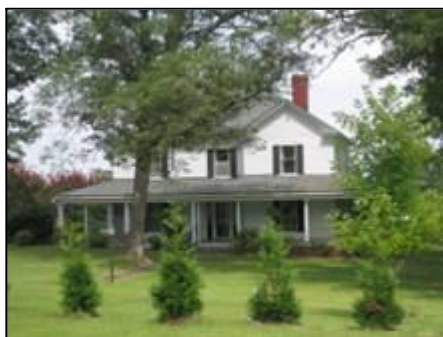
Alious Mills House and Store, 3529 Beaver Dam Rd

This asymmetrically-massed two-story frame house with hipped roof is at the center of a farm complex that includes a store. The house has a cross gable on the façade and a hipped-roof wrap porch that is supported by Doric columns.

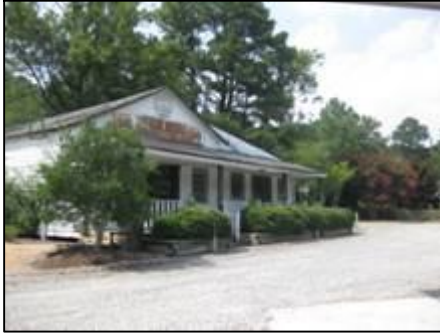
Green Level Community Store, 8401 Green Level Church Road

This early-twentieth-century frame store has a vernacular commercial form with later additions. The early gable-fronted store has a shed-roofed extension on a side elevation. A shed-roofed porch that extends the width of the façade unifies the two sections. The entrance is by double-leaf glazed doors.

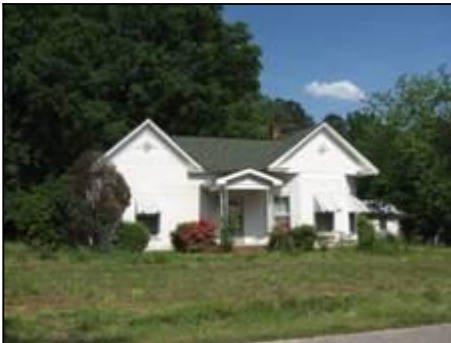
8400 Green Level Church Rd

This is a one-story, three-bay frame house with a side gable and two projecting gabled bays on either end of the façade. Each cross gable has cornice end returns and a diamond-shaped louvered vent in the peak of the gable. One is atop a bay that is flush with the façade, the other tops a canted three-sided bay. Between them is a central entrance with a single-leaf door sheltered by a one-bay gabled porch.

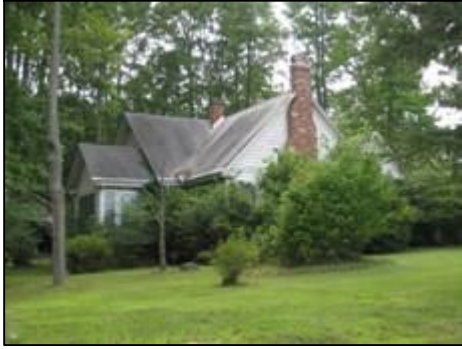
8425 Green Level Church Road

This house, reminiscent of the Tudor Revival-style, has a front gabled façade with a projecting gabled entrance pavilion flanked by a step-shouldered exterior chimney. There are cross-gabled projections on the side elevations.

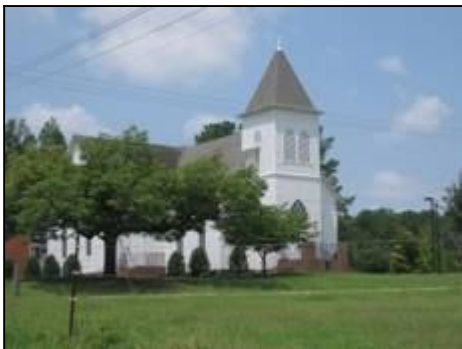
Green Level Baptist Church, 8501 Green level Church Road

The Green Level Baptist Church is a large Gothic Revival frame church with a front gable with a projecting tower entrance centered on the gable. The tower terminates in a pyramidal-hipped spire. The double-leaf entrance has a lancet window above with tracery, and in the next stage of the tower are paired lancet louvers.

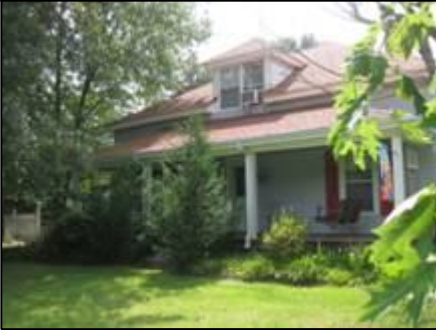
Albert Council House, 8621 Green level Church Road

This pyramidal cottage has a hipped-roof porch across the façade which is supported by square posts. Centered on the façade is a hipped wall dormer. The house retains its standing seam metal roofs. Windows are one-over-one sash and appear to be replacement.

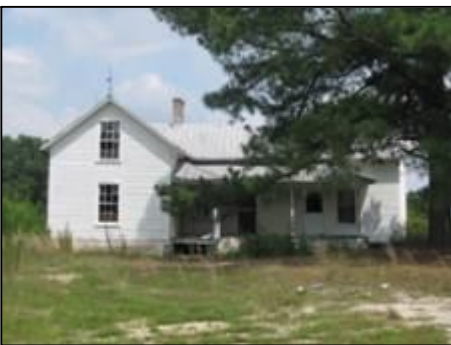
A. M. and Vallaria Council House, 8700 Green Level Church Rd

This one-and-one-half-story, frame, L-shaped house has a cross-gabled standing seam metal roof. The crux of the ell holds a hipped-roof, inset wrap porch supported by square posts. Windows are largely six-over-six.

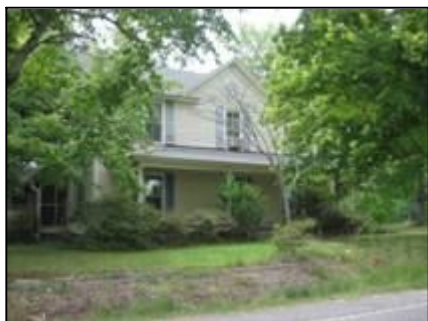
E. W. Hilliard House, 9021 Green Level Church Road

This two-story triple-A house has a hipped-roof porch supported on handsome Doric columns. The windows are predominantly two-over-two sash. The house has had several additions to the rear.

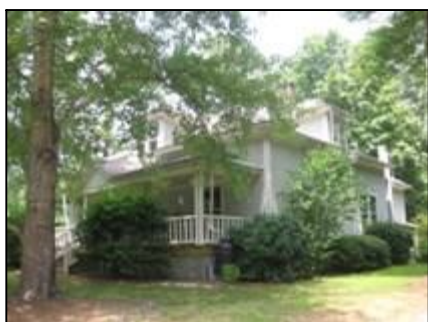
William Upchurch House, 9212 Green Level Church Rd

This pyramidal hip cottage was moved to this site in the 1960s. The house has hipped dormers and a hipped roof porch with a central gable at the entrance. The porch is supported by square posts with a square section balustrade.

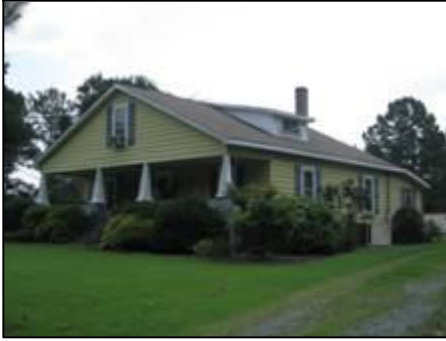
9625 Green Level Road

This front-gabled frame Bungalow has shed dormers on the side elevations. An inset porch under the large weatherboarded front gable is supported by pyramidal posts on brick piers. There is a large sash window in the front gable. The house has a shed-roofed addition to the rear.

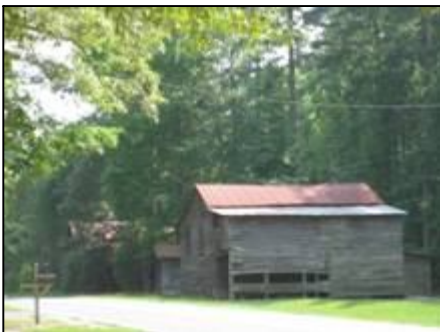
10109 Green Level Church Road

This farm complex on 50 acres includes a 1940s brick house with an array of pre-existing agricultural outbuildings including several barns and a tenant house in close proximity creating a complex of similar buildings.

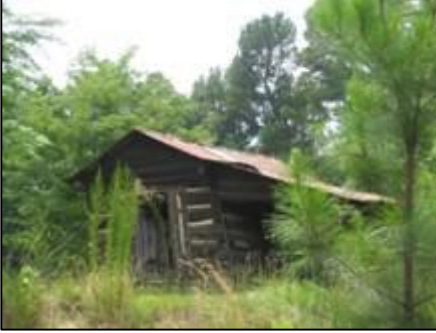
1511 Green Level to Durham Road

A few scattered outbuildings like this log building are all that remain of a larger farm complex, as the principal dwelling is no longer extant.

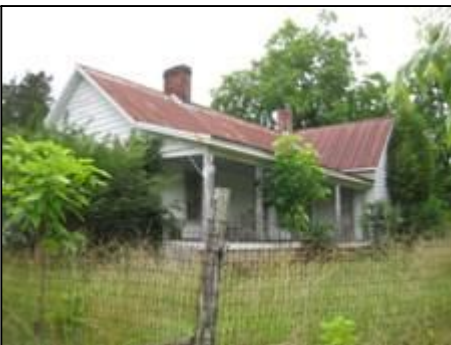
2129 South Alston Avenue

This one-story frame vernacular house is side-gabled with a projecting cross-gabled wing on the facade and an inset porch. The shed-roofed porch is supported by four minimally dressed logs. It has two interior chimneys with corbelled caps.

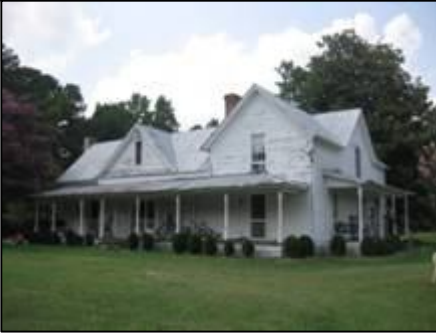
Yates-Carpenter House, 1116 White Oak Church Road

This evolved house is purported to have a log house at its core. Its form is an elaborated L shaped plan of two Carolina triple A houses. The façade has a shed-roofed porch and the elevation that is the “façade” of the lesser triple A has a porch that extends across the end gable of the first form. Roofs are standing seam metal.

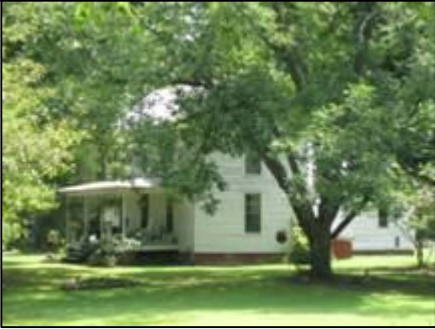
Yates Farm, 500 Futrell Drive

This turn-of-the-century I-house sits on a large agricultural tract and contains a series of outbuildings and dwellings. The house has gable returns and a hipped-roof porch on slender columns. The house retains its standing seam metal roofs.

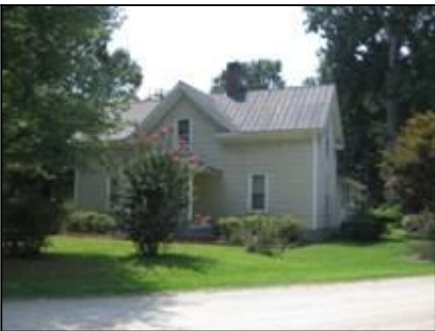
John Ferrell House, 1033 Ferson Road

This triple-A I-house has a broad cornice and all gables on the principal structure have generous cornice returns. The house is clad in asbestos siding and windows are one-over-one double hung sash. The house has a standing seam metal roof and one offset central interior chimney that pierces the roof ridge.

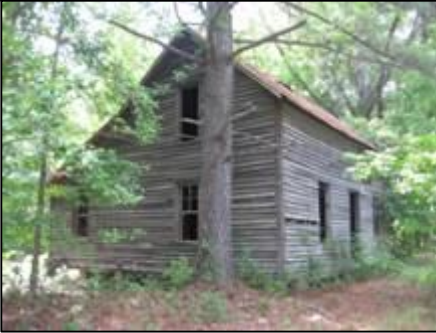
1117 East Ferrell

This one-and-one-half-story frame house has a side-gabled roof with a rear shed-roofed addition. The entrance is flanked by two windows; the windows that remain appear to be six-over-six sash. The house has a standing seam metal roof. It is open to the elements and greatly deteriorated though not overgrown.
